Address-Level Effects in Aguadilla, Puerto Rico, from the 1918 M_w 7.3 Earthquake and Tsunami

by Roland LaForge and William R. McCann

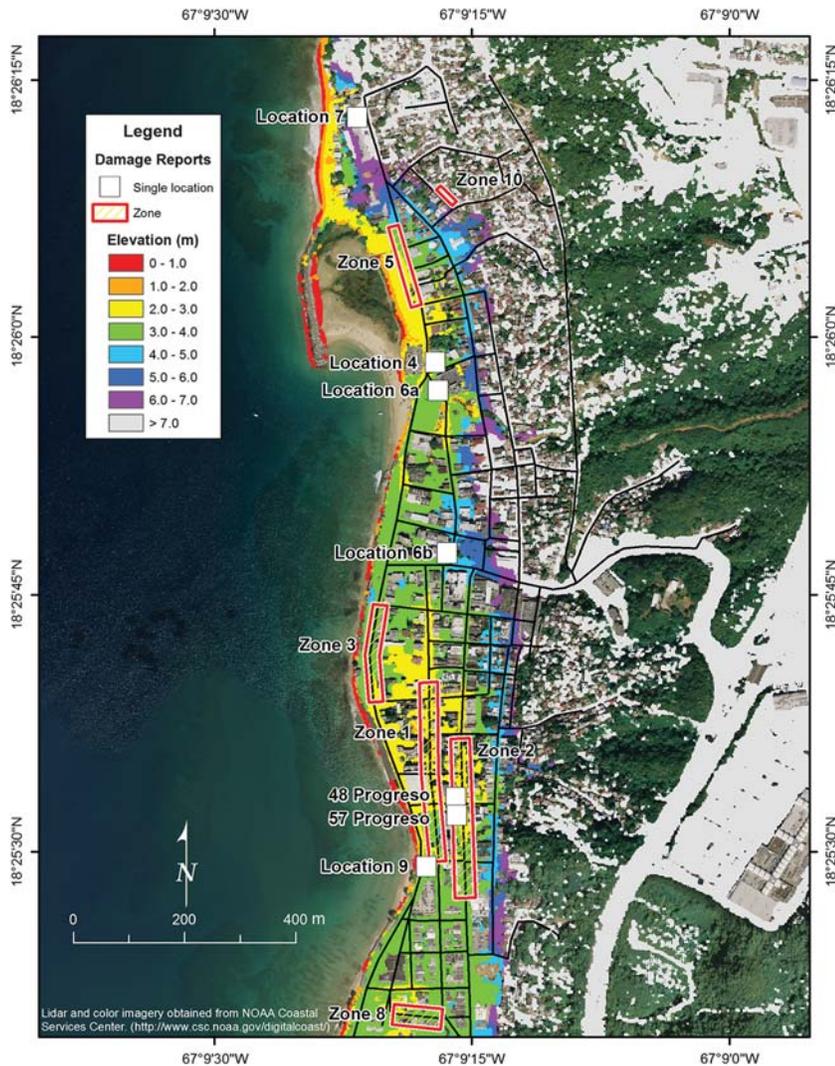
▲ **Figure 2.** Damage summary and elevations for Aguidilla.

and Calle Progreso (west to east). Along Calle Comercio, which runs along the shoreline, all petitions report complete destruction, often with the house completely carried away by the tsunami. This includes the Calle Sol reports (location 9) which are on the beach.

The second major observation is that, although limited in completeness, the reports of tsunami damage inland come from two zones: the area between Calle Stahl to the south and the Lafayette School, El Fuerte (the old Spanish fort), to the north, and the area along Calles Betances and Progreso to the south. The lidar map (Fig. 2) shows that these areas have elevations of less than 3 m. There are no reports of tsunami damage inland between these two areas, which is of higher (3–4 m) elevation, though such reports may have existed. However, a report from Calle Hernán Cortés (zone 8 in Fig. 2), in the 3–4 m elevation range, clearly indicates no tsunami effects.

Location 6 in Figure 2 apparently sustained no tsunami damage. This location corresponds to a specific address, 3 Calle de la Fuente. If this location is on the north end of Calle de la Fuente its elevation is 2–3 m; if on the south end it would be 4–5 m. As discussed above, location 6b is considered more likely. Location 4, precisely located at the intersection of Calles Stahl and Fósforo, is in the 3–4 m range and did not mention tsunami damage. The house at address 58 Calle Stahl, represented by zone 5 (exact location unknown, but north of Calle Fósforo), faced east and had its back to the shoreline. The report states that the kitchen and dining room at the back of the house were destroyed by the tsunami, with much structural damage to the rest of the house although the house was repairable. Because the precise dimensions and construction of this house were documented, it may prove valuable in estimating the physical characteristics of the tsunami as it hit this location, which is at an elevation of 3–4 m.

To the south, zones 1 and 2 show progressive tsunami effects from west to east. Along Calle Betances (zone 1), which lies 30–70 m from the shoreline, houses closest to the beach were totally destroyed, while those to the north were knocked off their foundations and pushed inland. The house with the lowest address number, probably in the northern part of zone 1, though severely damaged, did not mention tsunami effects. Figure 5, a photo taken looking south from the south end of Calle Betances, shows what houses along the street looked like, albeit 20 years before the earthquake. Some of the Betances damage reports may be for houses shown in this photo.

Along Calle Progreso about 50 m to the east (zone 2), and about 70 m from the shoreline, the tsunami reached its maximum inland extent. At 48 Progreso (Fig. 3), water damage was claimed, but because the inspector could not detect it after the owner repaired the damage, it must have been minimal. At 56 Progreso, the inspector claimed the water came up to within 6 ft of the house, and denied a claim for water damage. At 57 Progreso (Fig. 3), water carried away clothing and furniture. At 61 Progreso, no damage was detected, and the claim was denied. These reports clearly identify this localized area as where the extent of inundation was reached, in this part of town. The area lies 70–80 m from the shoreline, and at an elevation of no more than 4 m.

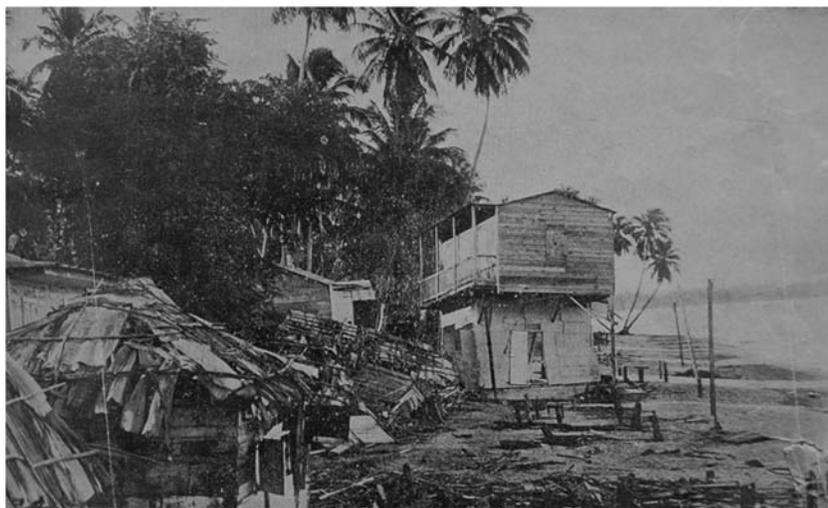
▲ **Figure 4.** Photo from Puerto Rico Ilustrado number 452, showing shoreline damage near zone 3 in Figure 2.

the structure remaining. Figure 4, from Puerto Rico Ilustrado issue number 452, shows shoreline damage in the La Ñamera district, whose exact location is unknown, but from the shoreline in the background is probably near where modern Calle Rogelio Castro (Fig. 3) meets the sea. Evident from this photo is that some houses were knocked of their stilt foundations, but they remained more or less intact and could be moved back to their original locations, as confirmed in some of the damage reports. Another observation is that palm groves and other vegetation

along the shoreline appears to be dense and may have impeded the tsunami movement inland. Figure 5, looking south from the south end of Calle Betances, also shows dense tree and vegetation growth along the shoreline.

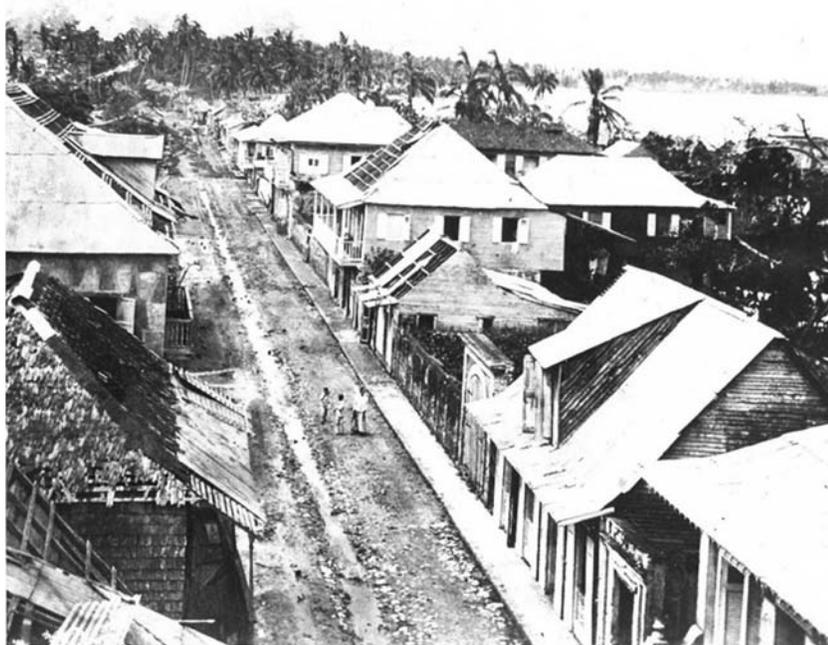
Figure 5 is an 1899 photo looking south from the southern end of Calle Betances, probably from near Calle Concepción. It gives an idea of architectural styles and building practices of this neighborhood, albeit 20 years before the earthquake. The photo was probably taken to show roof damage due to a severe hurricane of that year.

▲ **Figure 5.** Photo from San Juan archives looking south from the south end of Calle Betances (near location 9 in Fig. 2) in 1899.
