Floods of September 6, 1960, in Eastern Puerto Rico

GEOLOGICAL SURVEY
CIRCULAR 451

By Harry H. Barnes, Jr., and Dean B. Bogart

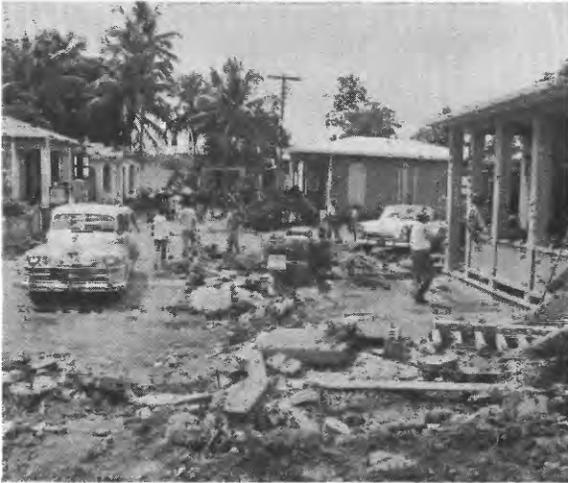
Figure 2.—Flood debris in a street in Humacao.

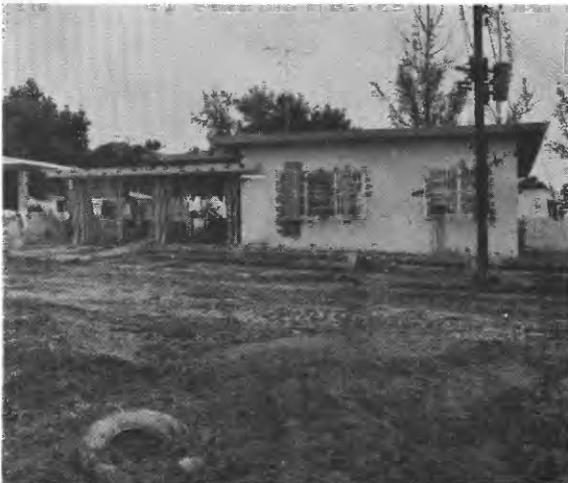
Figure 3.—After the recession of the floodwaters at the northwest edge of Humacao. Note the man pointing to the high-water mark above his head.

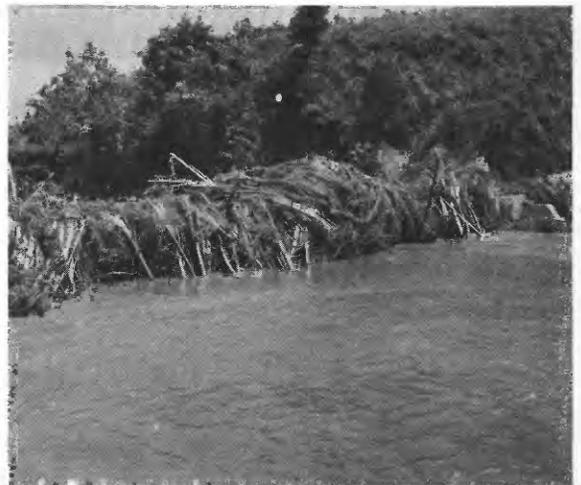
Figure 4.—Bridge opening completely clogged, mostly by bamboo.

Bamboo is used rather extensively throughout the island to check roadside erosion and protect streambanks. The dislodged bamboo that was swept away by streams proved to be a menace to bridges and culverts. In many places bridge and culvert openings were completely blocked by the debris (fig. 4), forcing floodwaters over or around the structures, and resulting in large washouts.

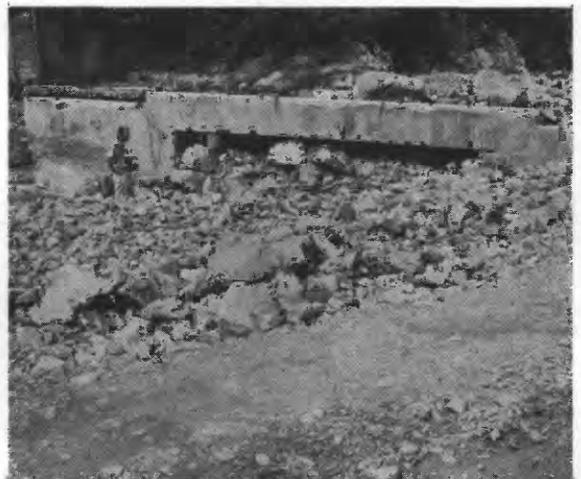
Figure 5.—View from downstream side of bridge on Rio Turabo near La Plaza. Note the rock-filled channel above the bridge.

riverbed above the highway and bridge level (fig. 5) at points between Caguas and La Plaza. Sharply angled fresh rock, in addition to the usual rounded and bleached-out boulders, was particularly noticeable in the channels. Several of the older citizens living along the Rio Turabo north of La Plaza indicated that the flood on September 6 was the greatest known.

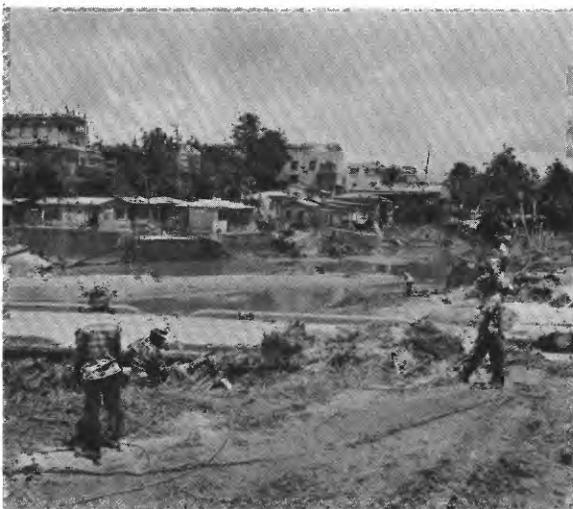
Figure 7.—View showing damage to floodwall along left bank at Rio Valenciano in Juncos.

Peak discharges in the middle reaches of the Rio Valenciano rank among the highest known for streams that drain from 6 to 15 square miles. At Juncos, the floodwall protecting the city along the left bank of the river was overtopped and extensively damaged (fig. 7). Downstream from the mouth of Rio Valenciano, floodwaters of Rio Gurabo overtopped the bridge handrails at Highways 185 and 181, and washed out the bridge approaches. The gaging station at Gurabo was damaged and put out of action. The railroad bridge 1 mile downstream was destroyed.

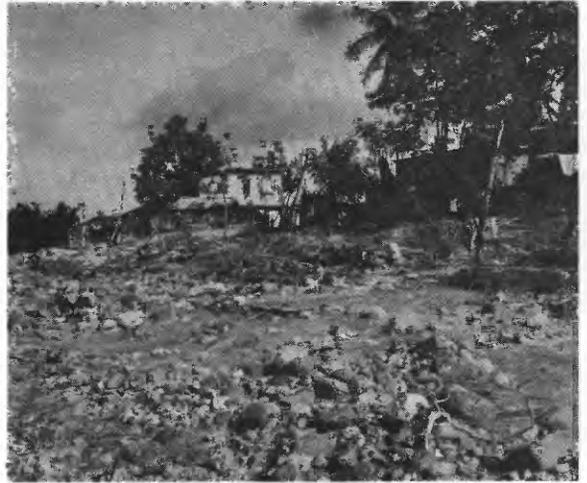
Figure 8.—Heavily eroded and redeposited bank of Rio Grande de Loiza at San Lorenzo. Several houses formerly occupied this area.

At San Lorenzo the floodwaters of Rio Grande de Loiza destroyed practically all houses and buildings in its path (fig. 8). The only evidence left of previous habitation was partly exposed foundations along the boulder- and debris-littered banks.

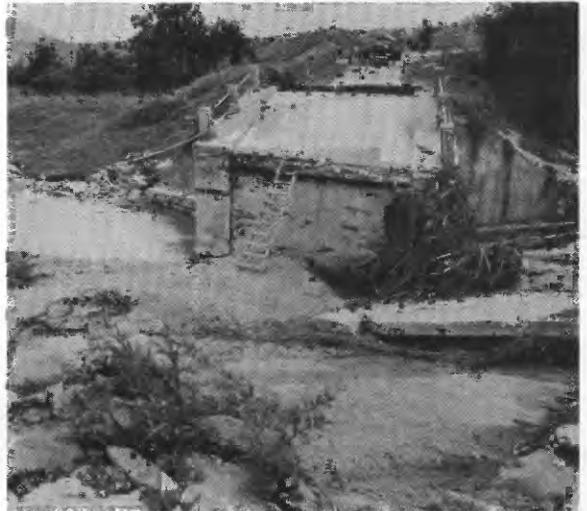
Figure 9.—Bridge on Rio Limones near Limones. Wingwall from left side was found intact about 50 feet downstream; the remains of the wingwall from the right side can be seen in the foreground.
