FLOODS AT HUMACAO, PUERTO RICO

By
Miguel A. Lopez
1967

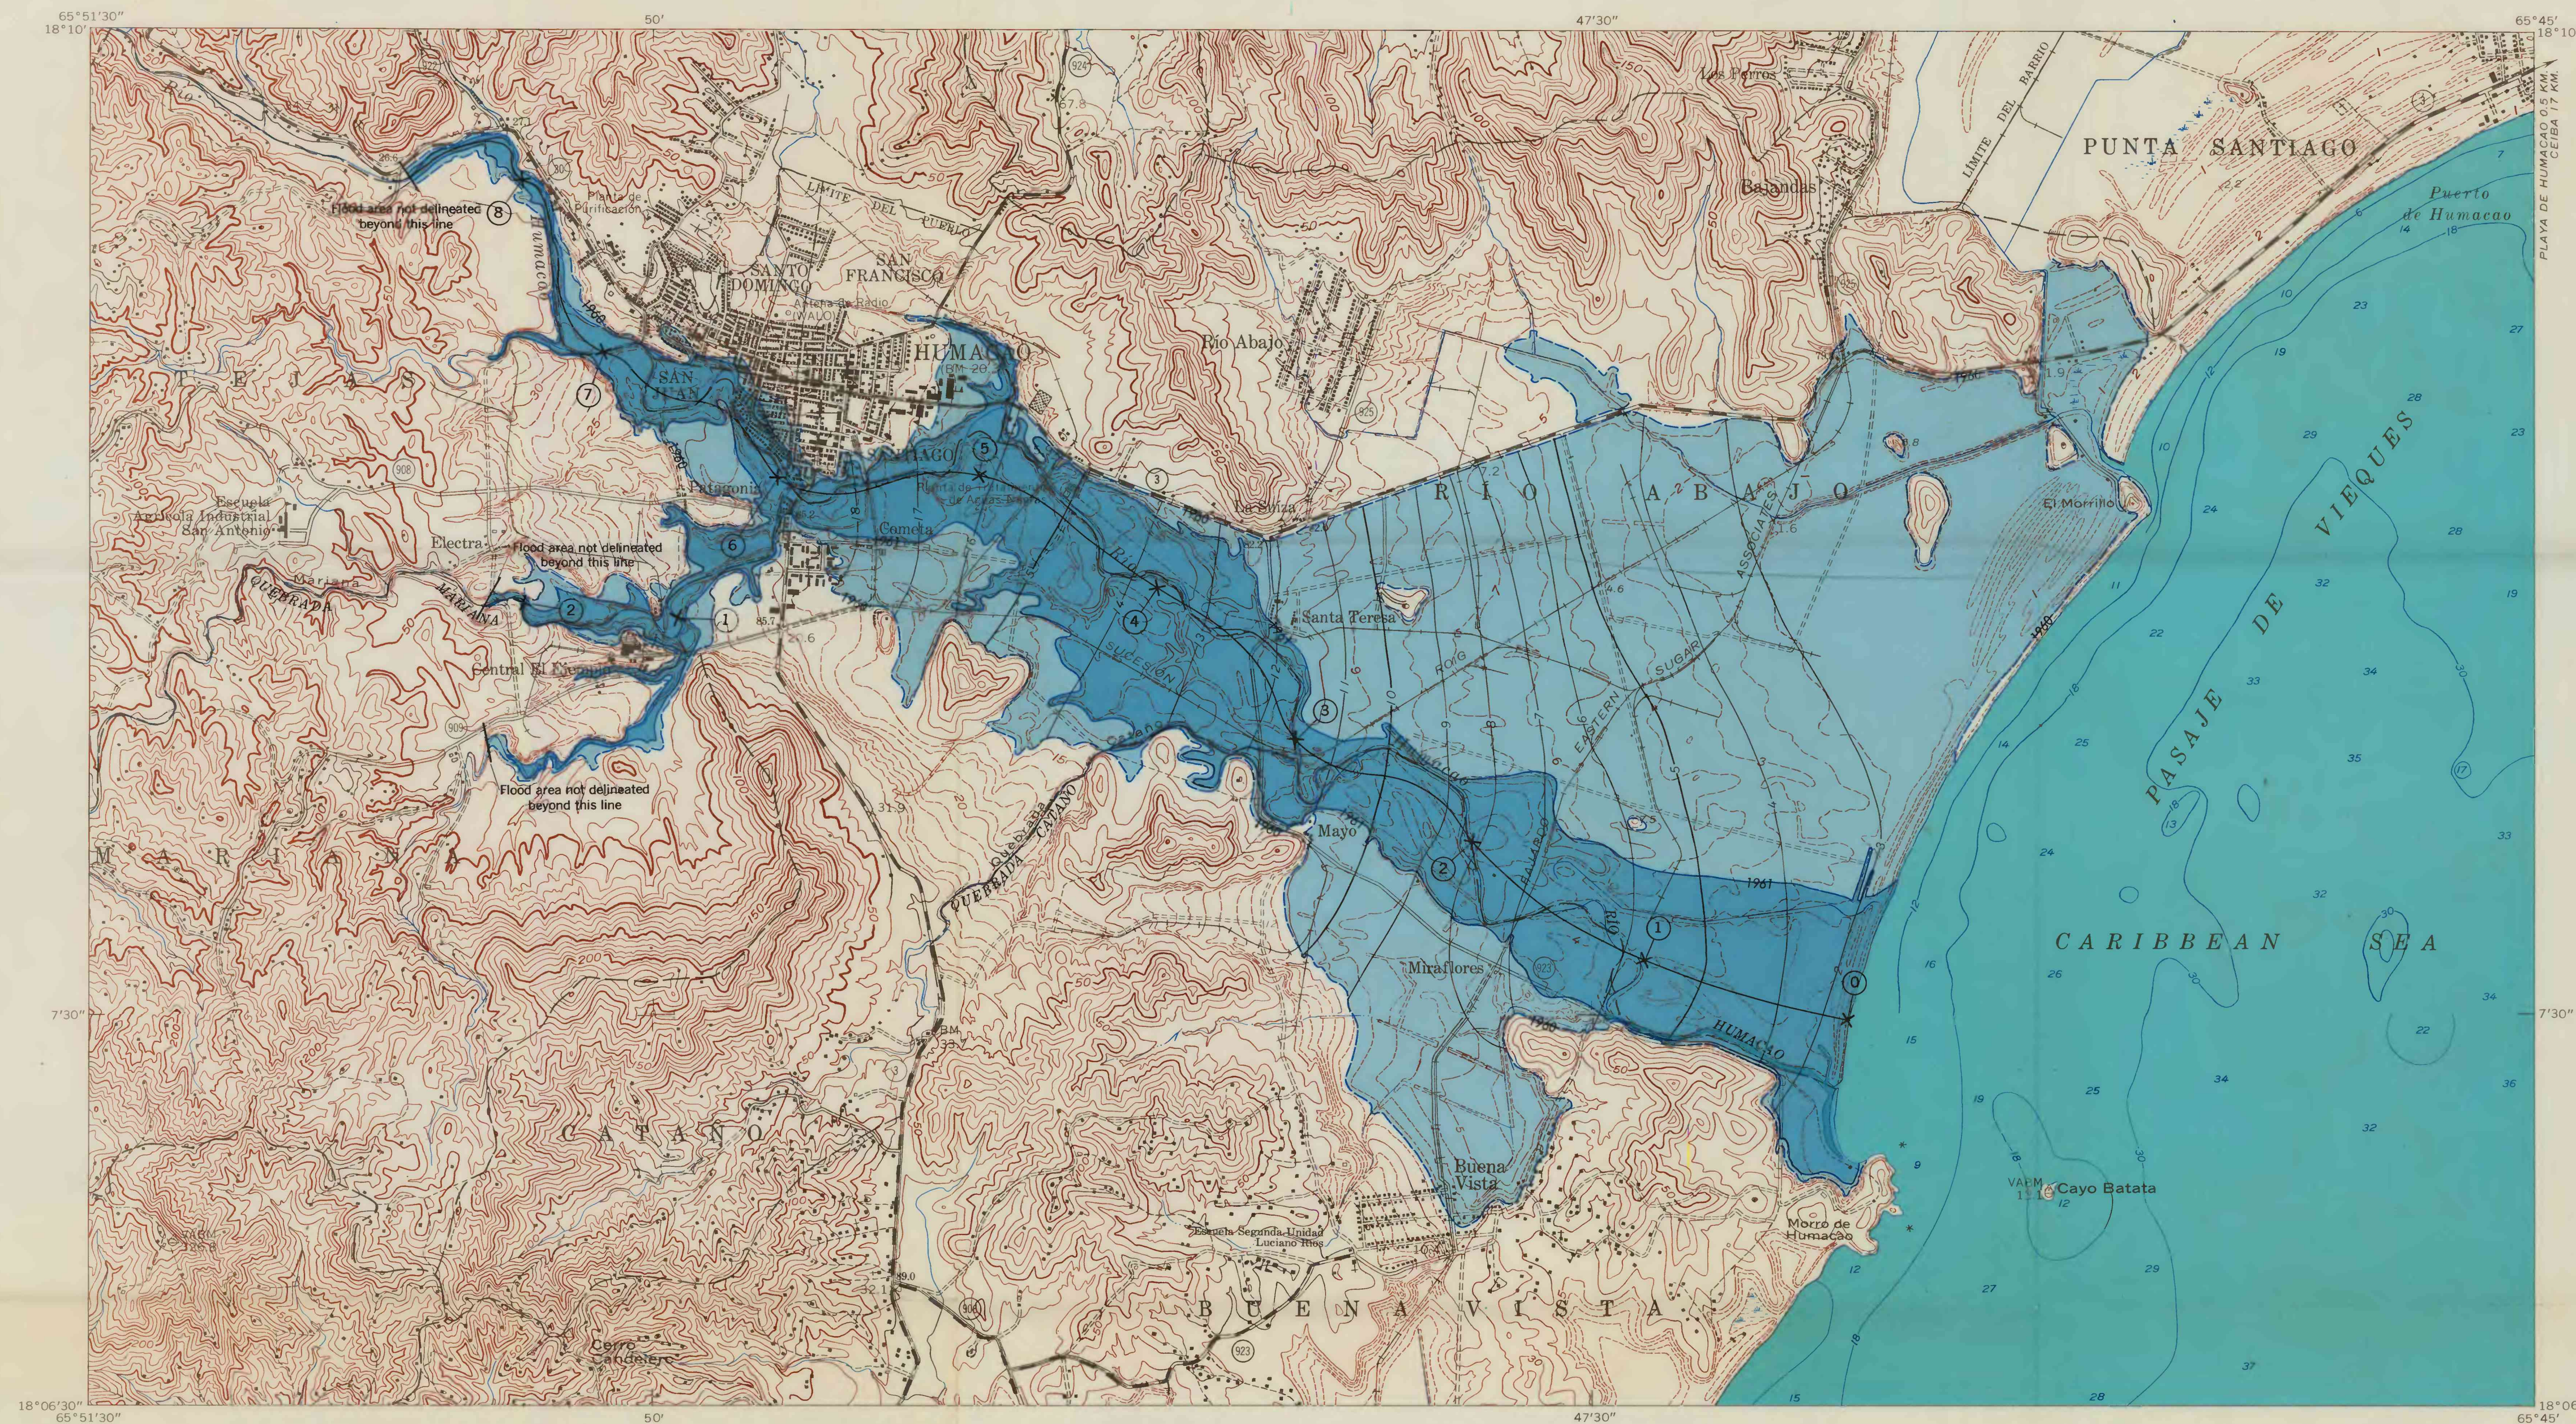
The areas inundated by Rio Humacao, Quebrada Mariana, and Quebrada Cataño during the floods of September 6, 1960, and August 27, 1961, are shown on the topographic base map to record the flood hazard graphically. The flood of September 6, 1960, is the highest since at least 1911. Greater floods are possible, but definition of their probable overflow limits was not undertaken in this report.

Depth of flooding.—The depth of inundation during the 1960 flood at any point along Rio Humacao and Quebrada Mariana can be determined by subtracting the ground elevation at the point from the flood elevation indicated by the profile or by the water-surface contour line. The approximate ground elevation can be determined from ground contours shown on the map, although more accurate elevations can be obtained by leveling to nearby bench marks.

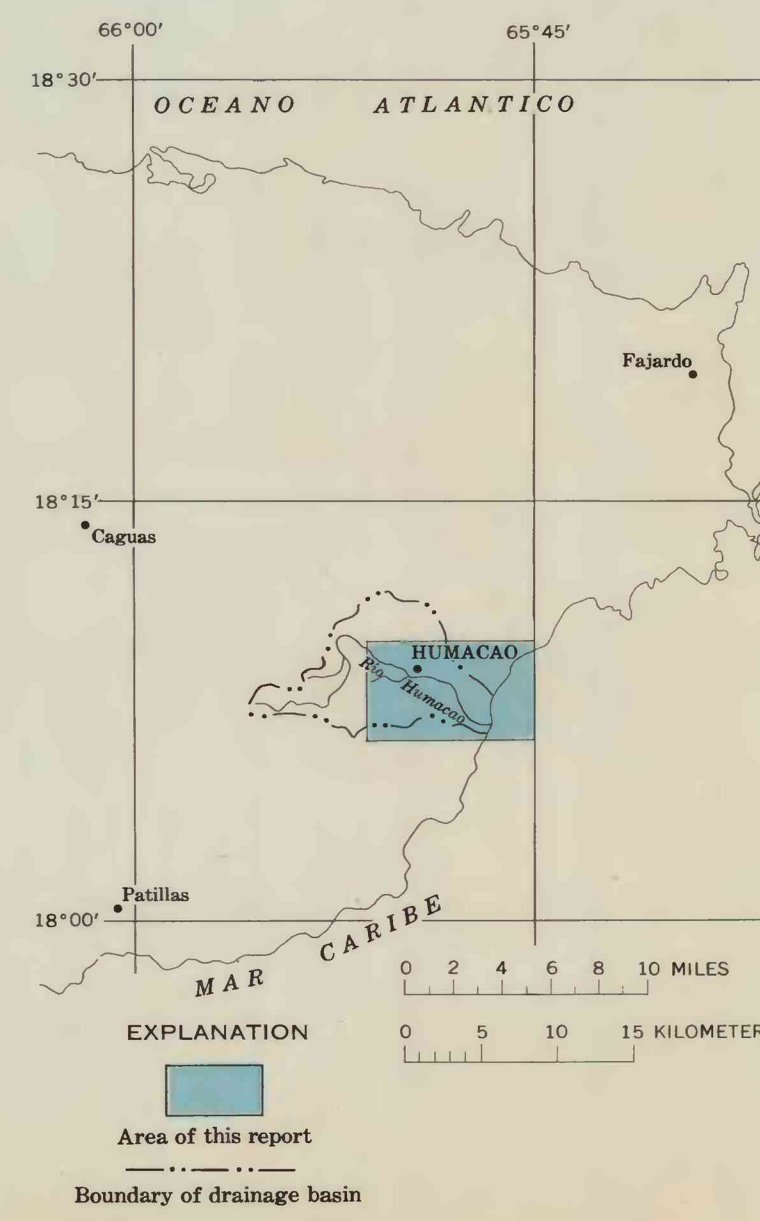
FIGURE 1.—Rio Humacao drainage basin.

this study in relation to the Rio Humacao drainage basin. Rio Humacao flows generally eastward through the deeply weathered plutonic rock of the interior uplands and enters the alluvial flood plain 8 kilometers from the mouth. The watershed land is used for pasture and growing sugarcane, and the land at higher elevations is largely undeveloped

Rio Humacao drainage basin.—Figure 1 shows the area of

tropical forest. In a distance of 19 kilometers the streambed elevation of Rio Humacao drops from about 300 meters to 15 meters at the confluence of Quebrada Mariana in the City of Humacao. From Humacao to the sea, a distance of 7.5 kilometers, the river meanders through a typical coastal flood plain. The major tributary, Quebrada Mariana, flowing in a narrow valley for its full length, enters the Rio Humacao flood plain at Humacao. The drainage area of Rio Humacao at Highway 3 is 17.3 square miles (including Quebrada Mariana) and at the mouth it is about 26 square miles.
