# Socioeconomic and Environmental Impacts of Landslides in the Western Hemisphere

*Robert L. Schuster and Lynn M. Highland*

***Open-File Report 01-276***

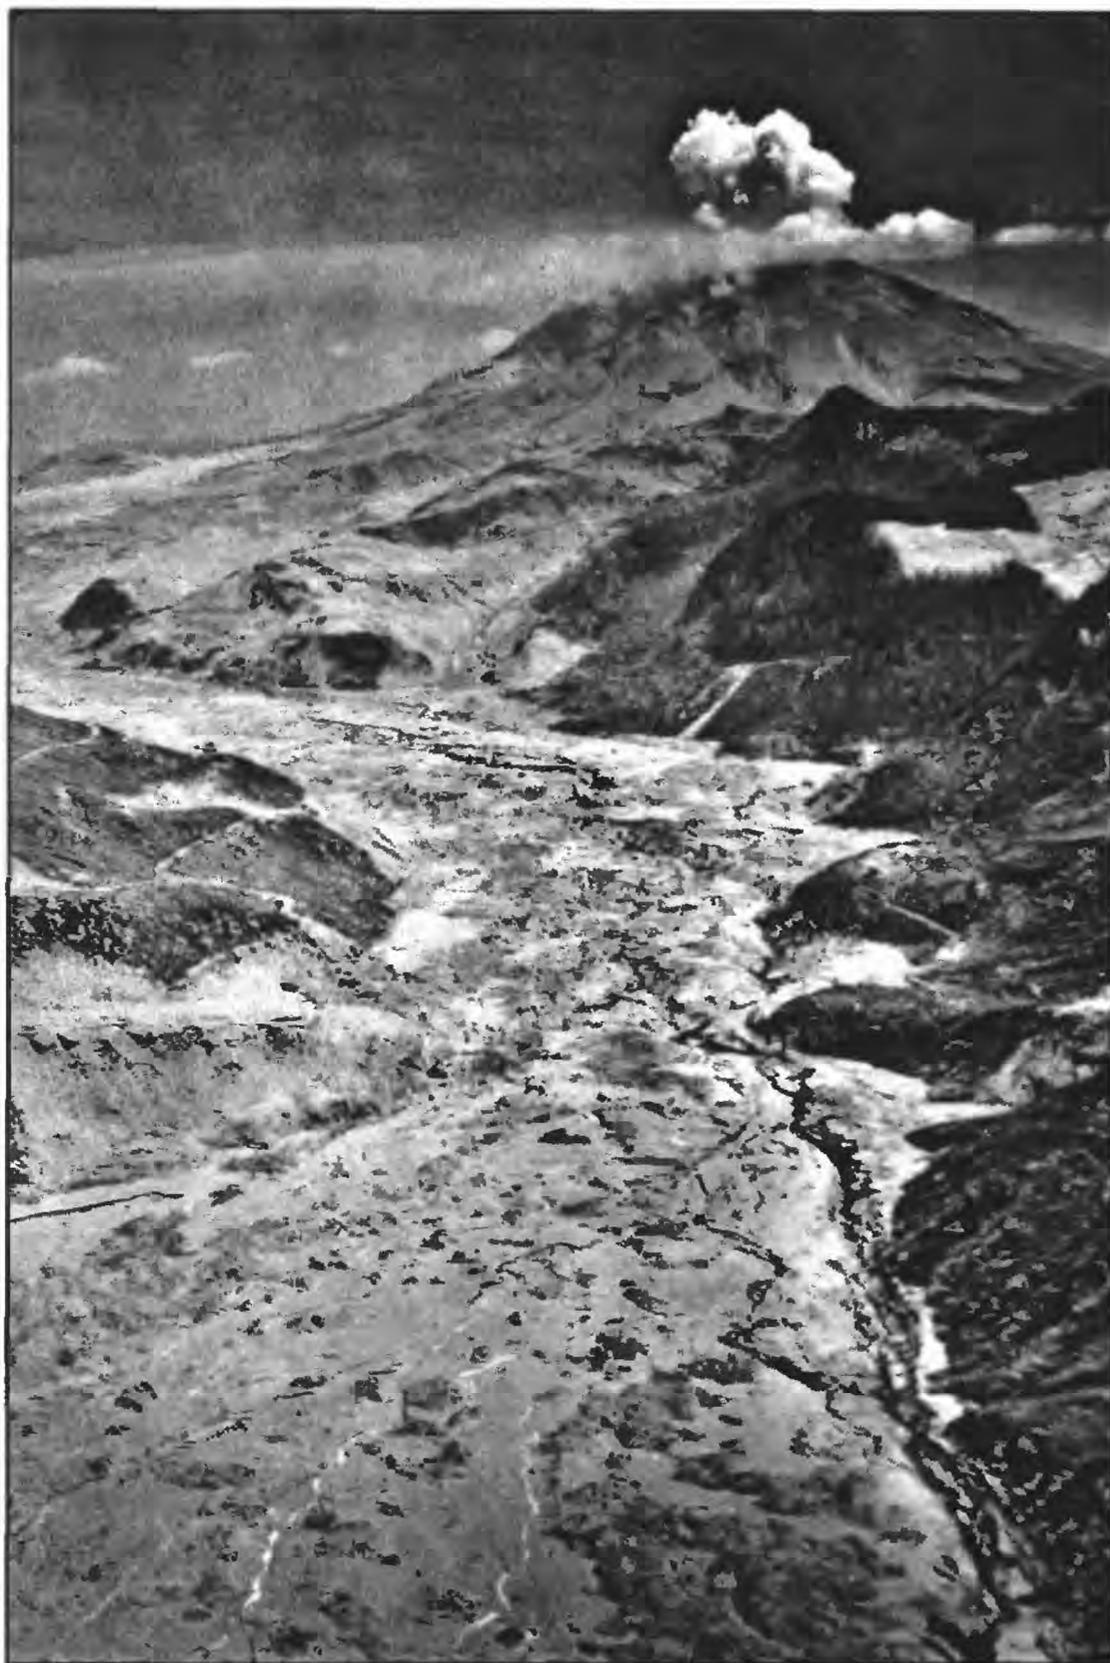
*Figure 1. Mount St. Helens debris avalanche in valley of North Fork Toutle river, State of Washington, U.S.A.: view east from terminus of avalanche toward devastated cone of the volcano. (May 1980 photo by R.M. Krimmel, U.S. Geological Survey)*

The May 1980 eruption of Mount St. Helens, a volcano in the State of Washington, caused the world's largest historic landslide, a 2.8-km<sup>3</sup> rock slide-debris avalanche (Fig. 1) that traveled about 22 km westward (Voight et al., 1983), destroying nine highway bridges, many kilometers of highways, roads, and railroads, and numerous private and public buildings (Schuster, 1983). The debris avalanche also formed several new lakes by damming the North Fork Toutle River and its tributaries. These lakes posed downstream hazards because of

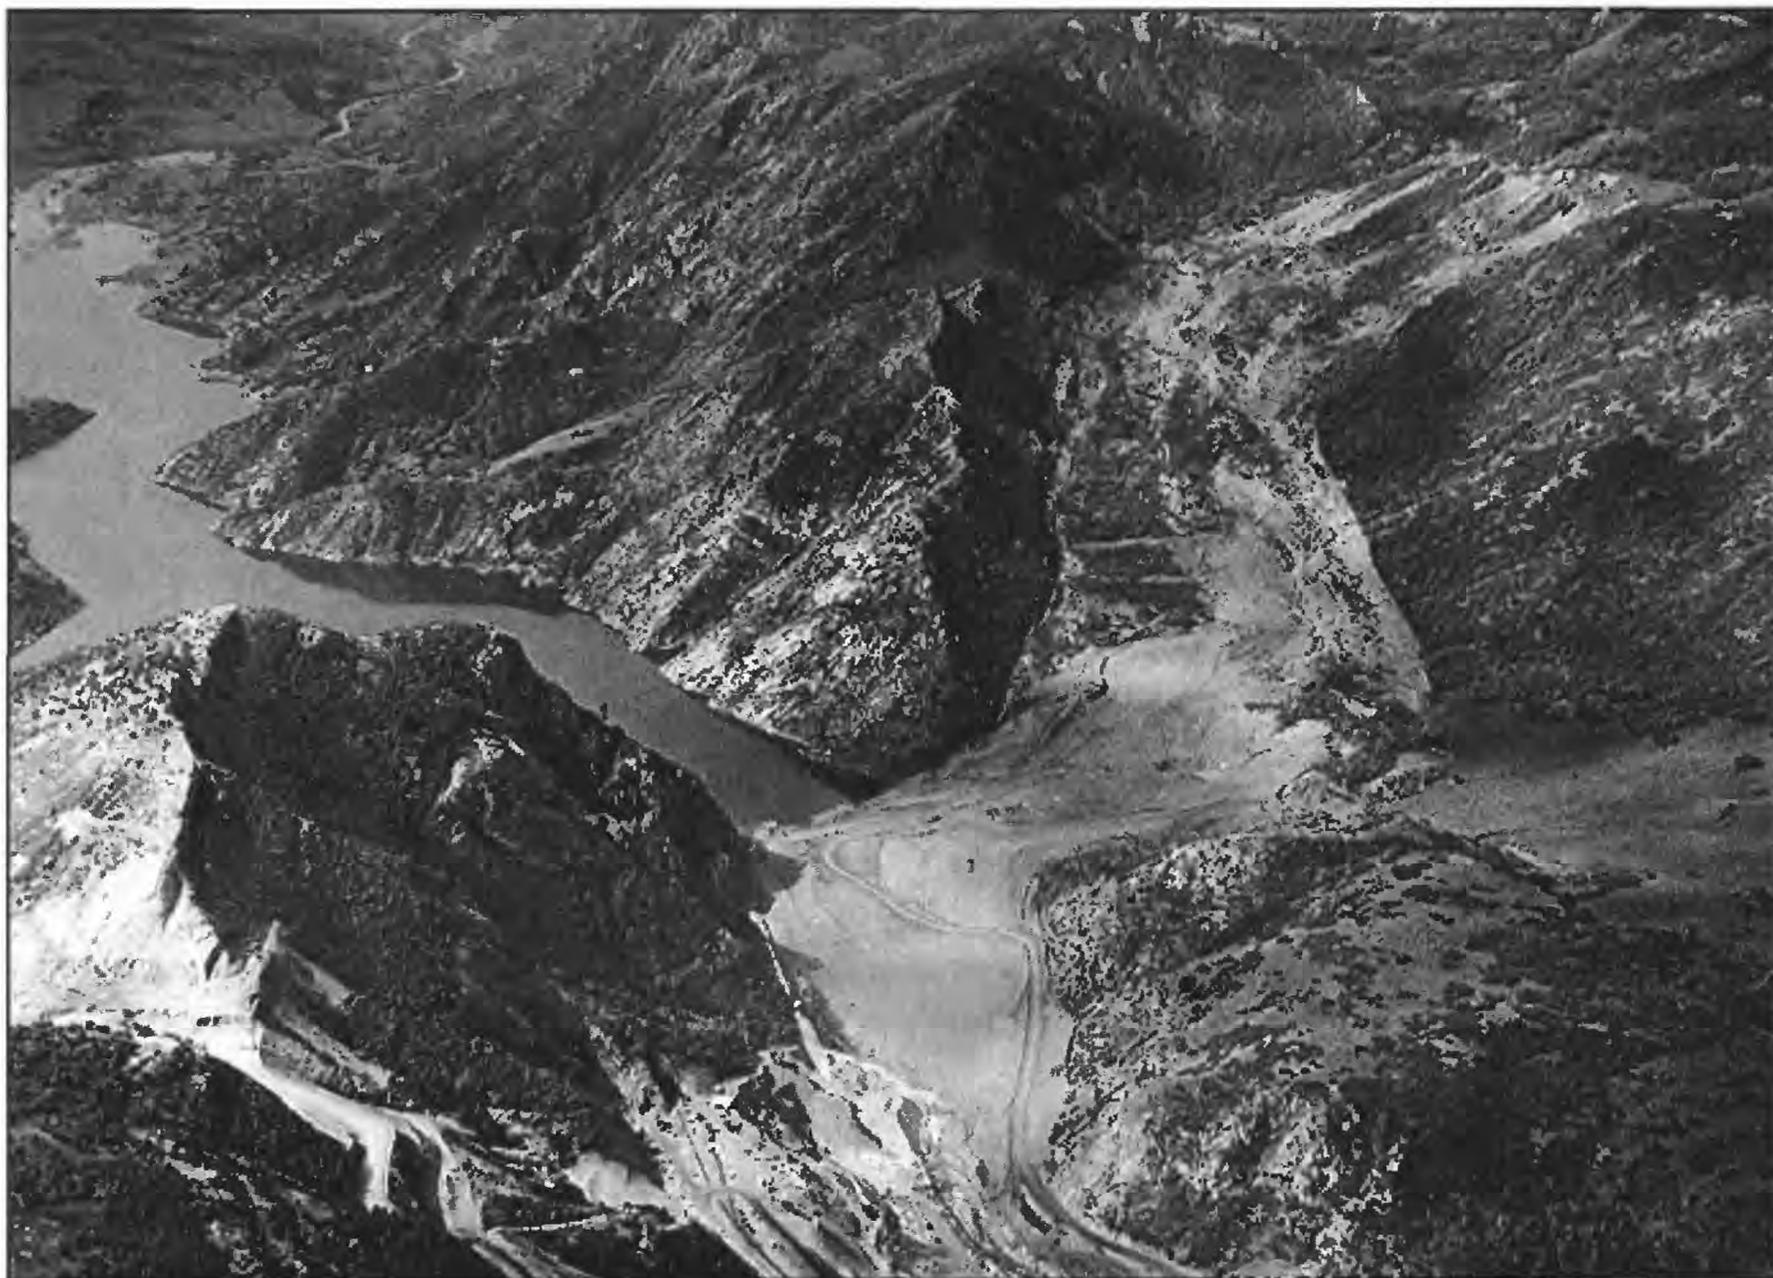
*Figure 2. The 1983 Thistle landslide, central Utah, U.S.A. Thistle Lake, which resulted from damming of the Spanish Fork River, was later drained as a precautionary measure. This view, taken about 6 months after the slide occurred, shows the realignment of the Denver and Rio Grande Western Railroad lines in the lower center and the large cut for rerouting U.S. Highway 6/50 on the extreme left side of the photo.*

Abnormally high precipitation in 1982-84 related to a strong El Niño Southern Oscillation caused thousands of landslides in mountain areas of the western United States. Anderson et al. (1984) estimated that total direct costs of landslides in the State of Utah in spring 1983 exceeded \$250 million (\$430 million). The April 1983 Thistle debris slide (Fig. 2), probably the world's most expensive individual

landslide, and the lake it formed by damming the Spanish Fork River severed three major transportation arteries: U.S. Highways 6/50 and 89, and the main transcontinental line of the Denver and Rio Grande Western Railroad (D&RGW). The D&RGW spent about \$40 million (\$69 million) to reestablish its line outside the devastated area, mostly to construct a twin-bore tunnel about 900 m long that bypassed the landslide and lake (Malone, 1983).

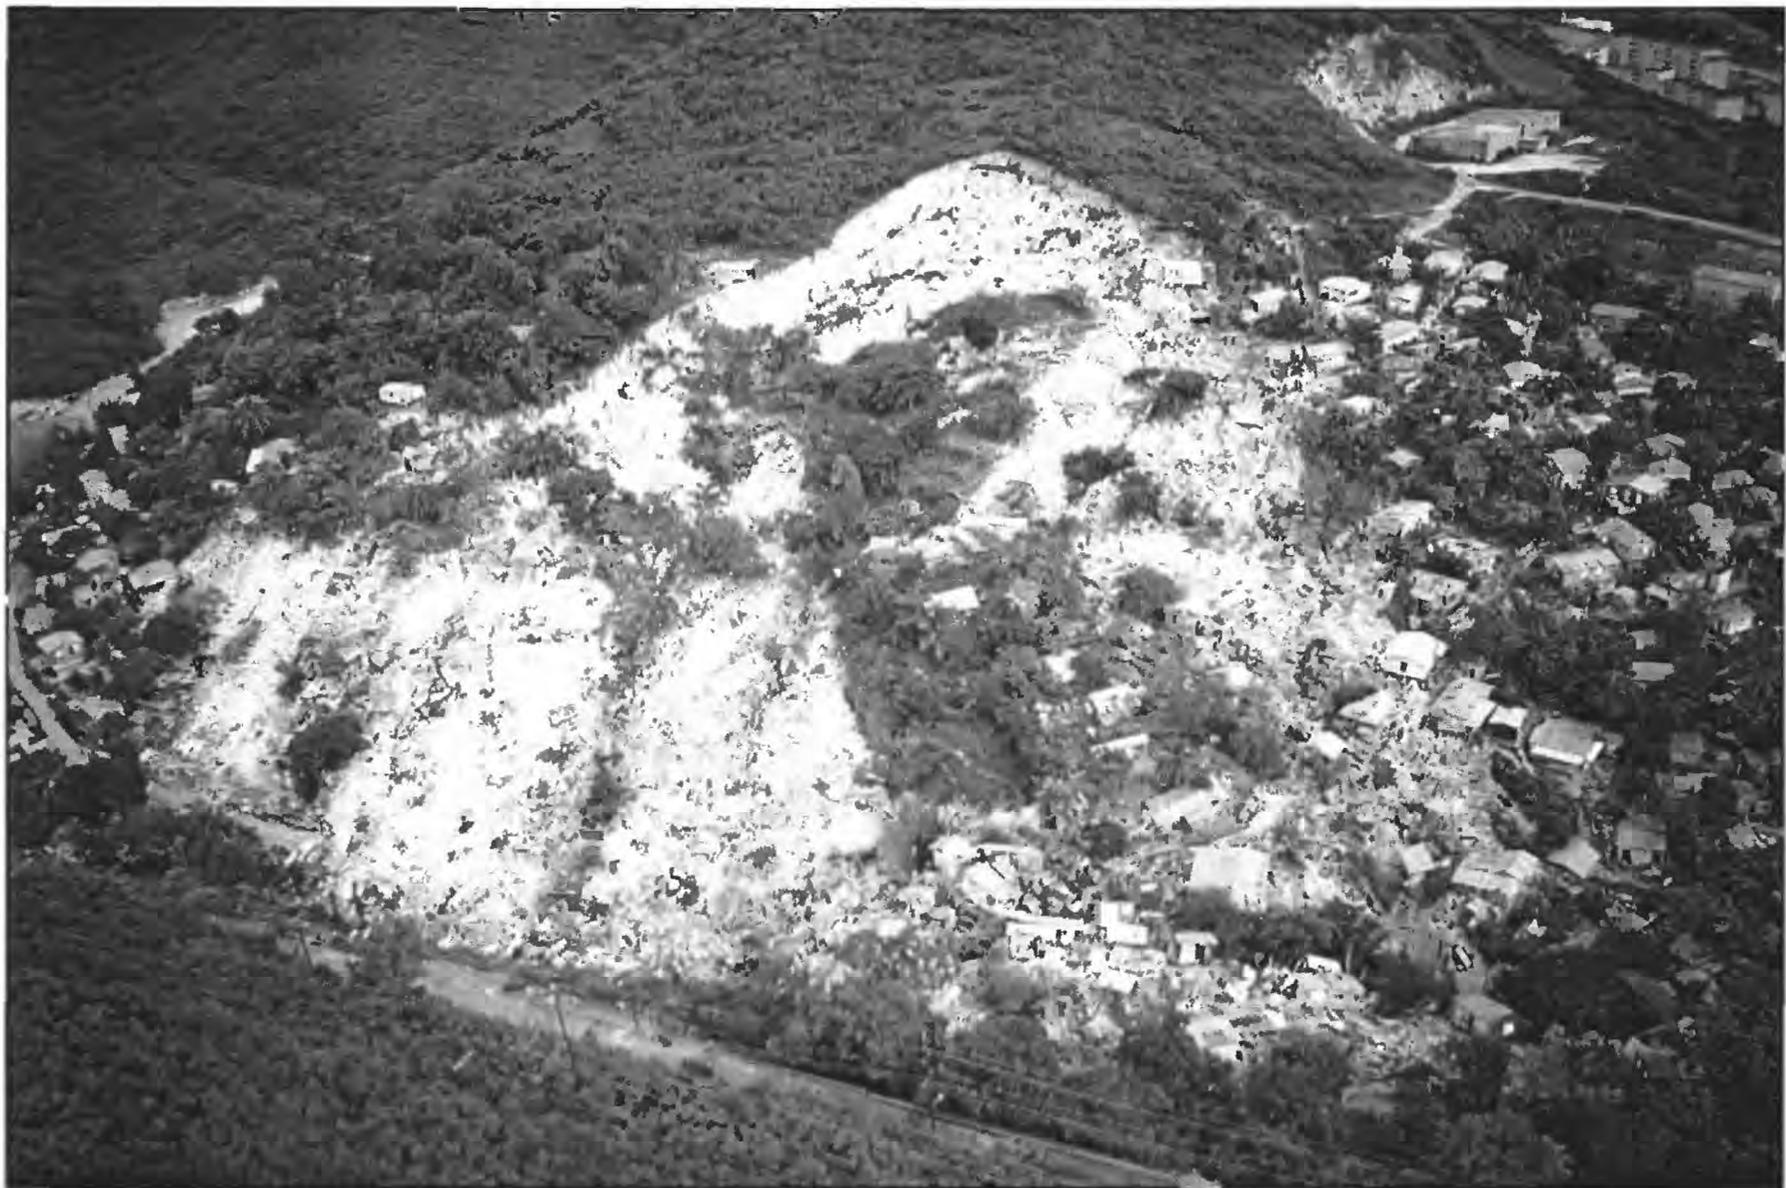
*Figure 3. The October 1985 Mameyes, Puerto Rico, rock slide, which killed at least 129 people. (Photo by R.W. Jibson, U.S. Geological Survey)*

Another Atlantic storm-caused landslide disaster occurred in October 1985 on the Caribbean island commonwealth of Puerto Rico when heavy rain from Tropical Storm Isabel caused a major rock slide (Fig. 3) that obliterated much of the Mameyes district of the city of Ponce on the south coast of the island. The slide killed at least 129 people and destroyed about 120 houses (Jibson, 1992). The death toll at Mameyes is the greatest in North American history from a single landslide.

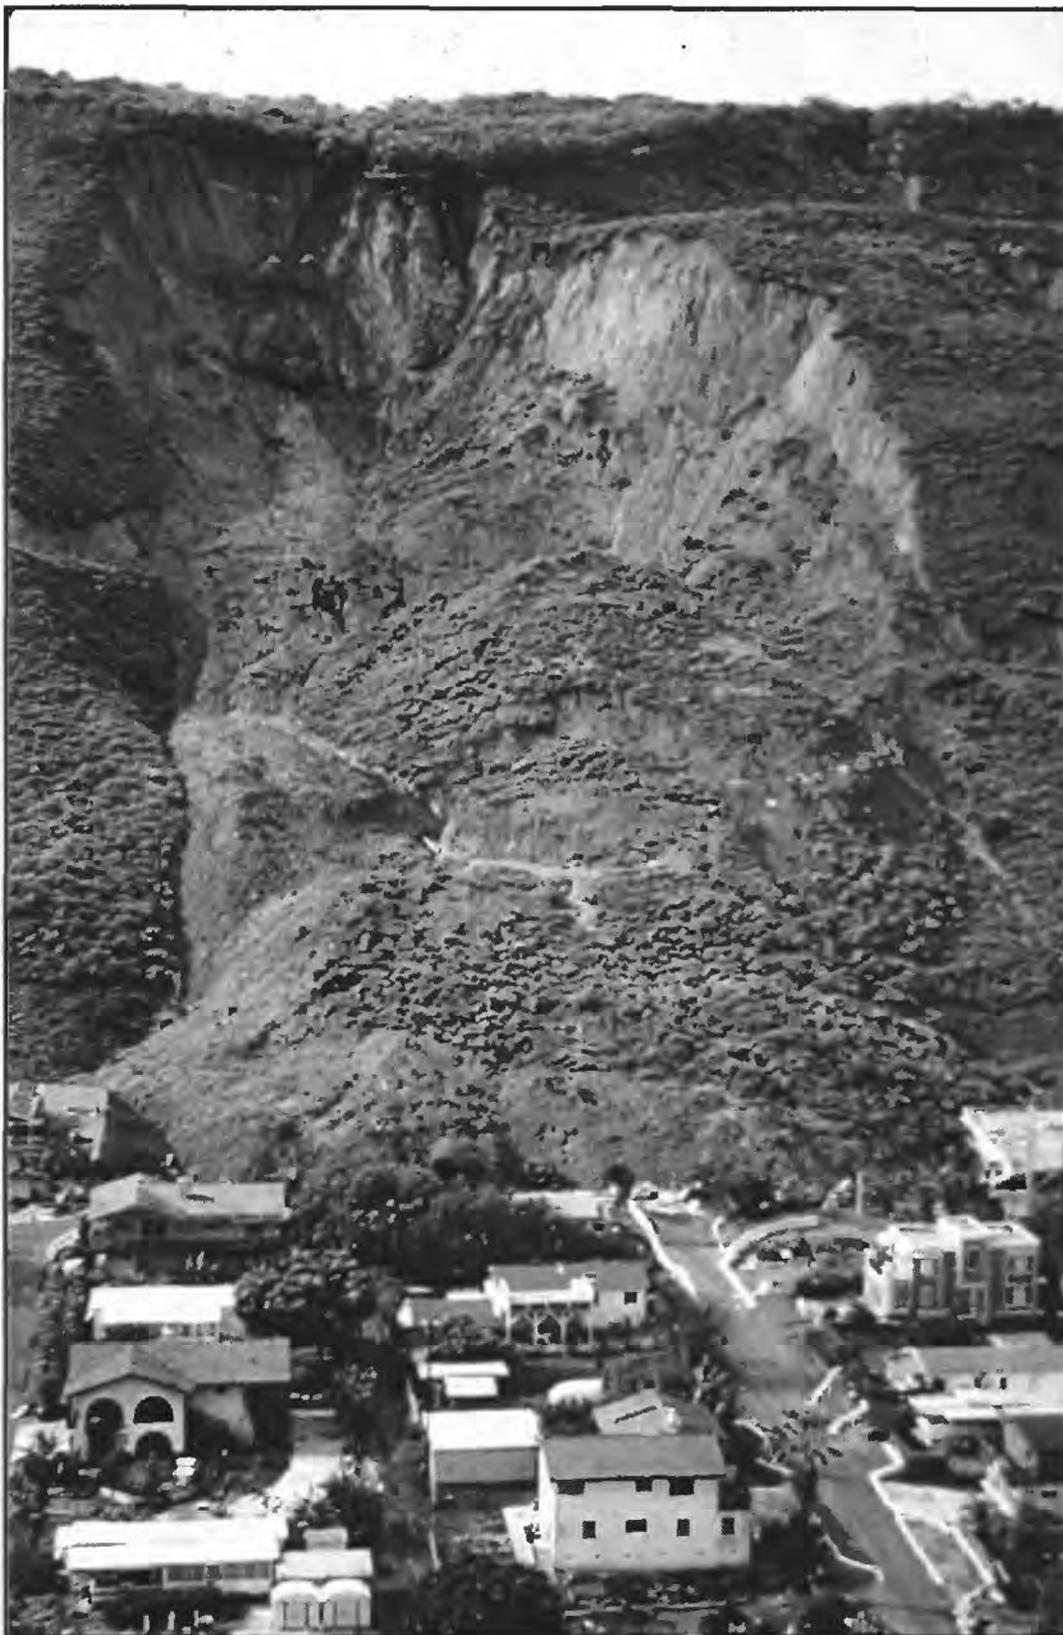
Figure 4. The 1995 La conchita landslide, southern California, U.S.A.

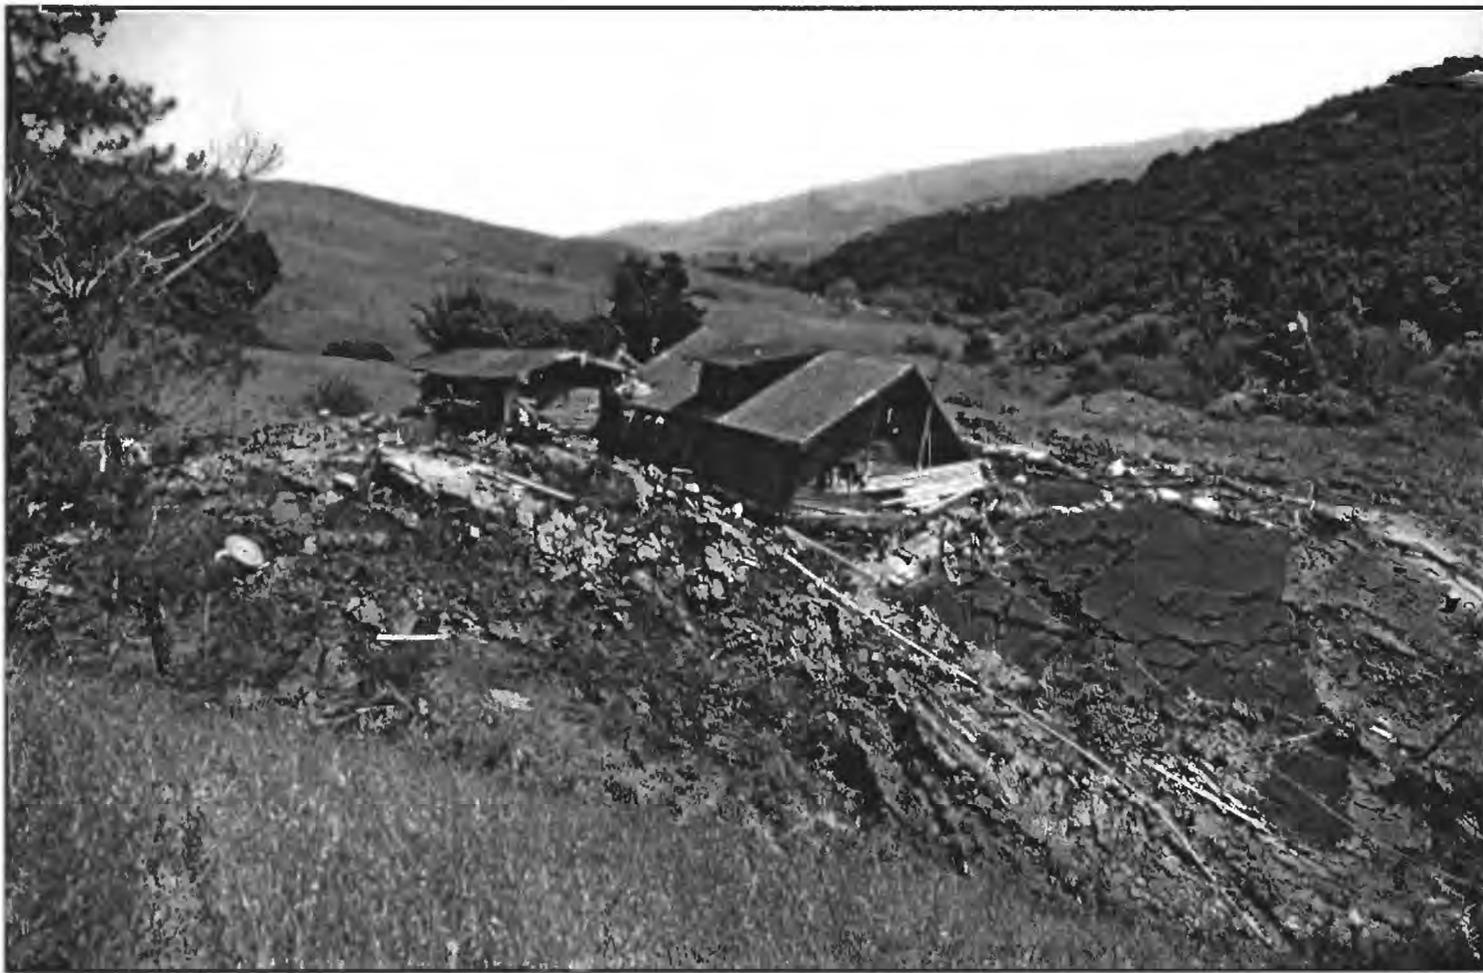
*Figure 5. Home destroyed by the April 1998 El Niño-triggered Anzar Road landslide, San Benito, California, U.S.A. (Schuster, et al., 1998).*

In the late winter and early spring of 1998, heavy rainfall associated with a strong El Niño again caused major landslide activity and resulting damage to housing (Fig. 5) and lifelines in the 10-county San Francisco Bay, California, region. Direct costs of landslide damage in the region totaled approximately \$156 million (\$163 million) (Godt and Savage, 1999).

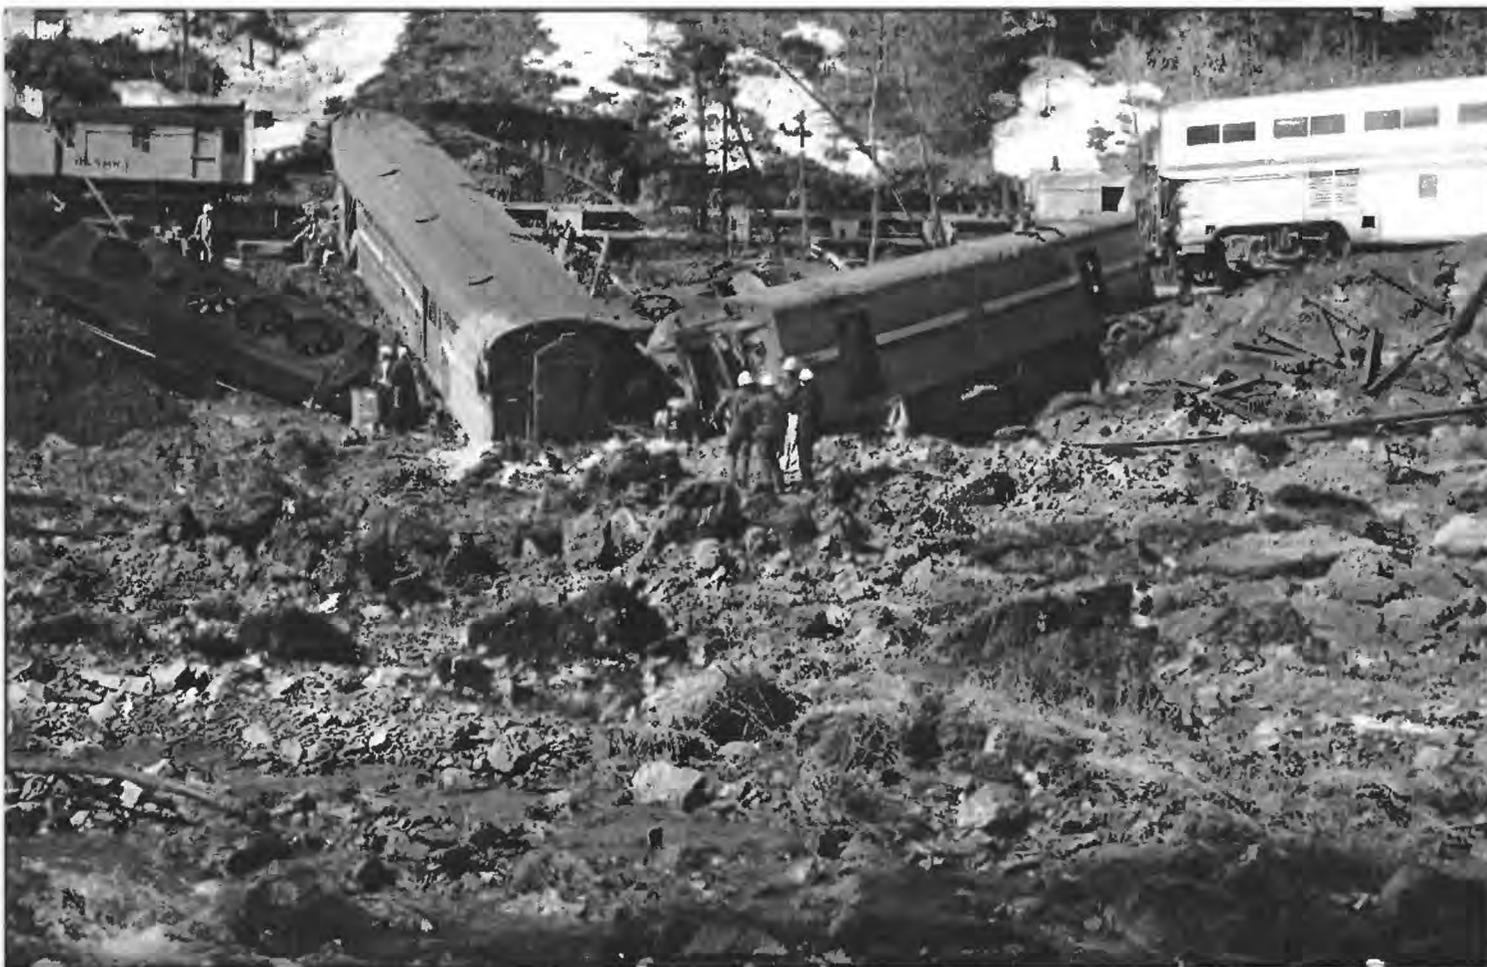
*Figure 6. A minor landslide caused the April 1985 derailment of the California Zephyr passenger train in Fraser Canyon, Central Colorado, U.S.A.*

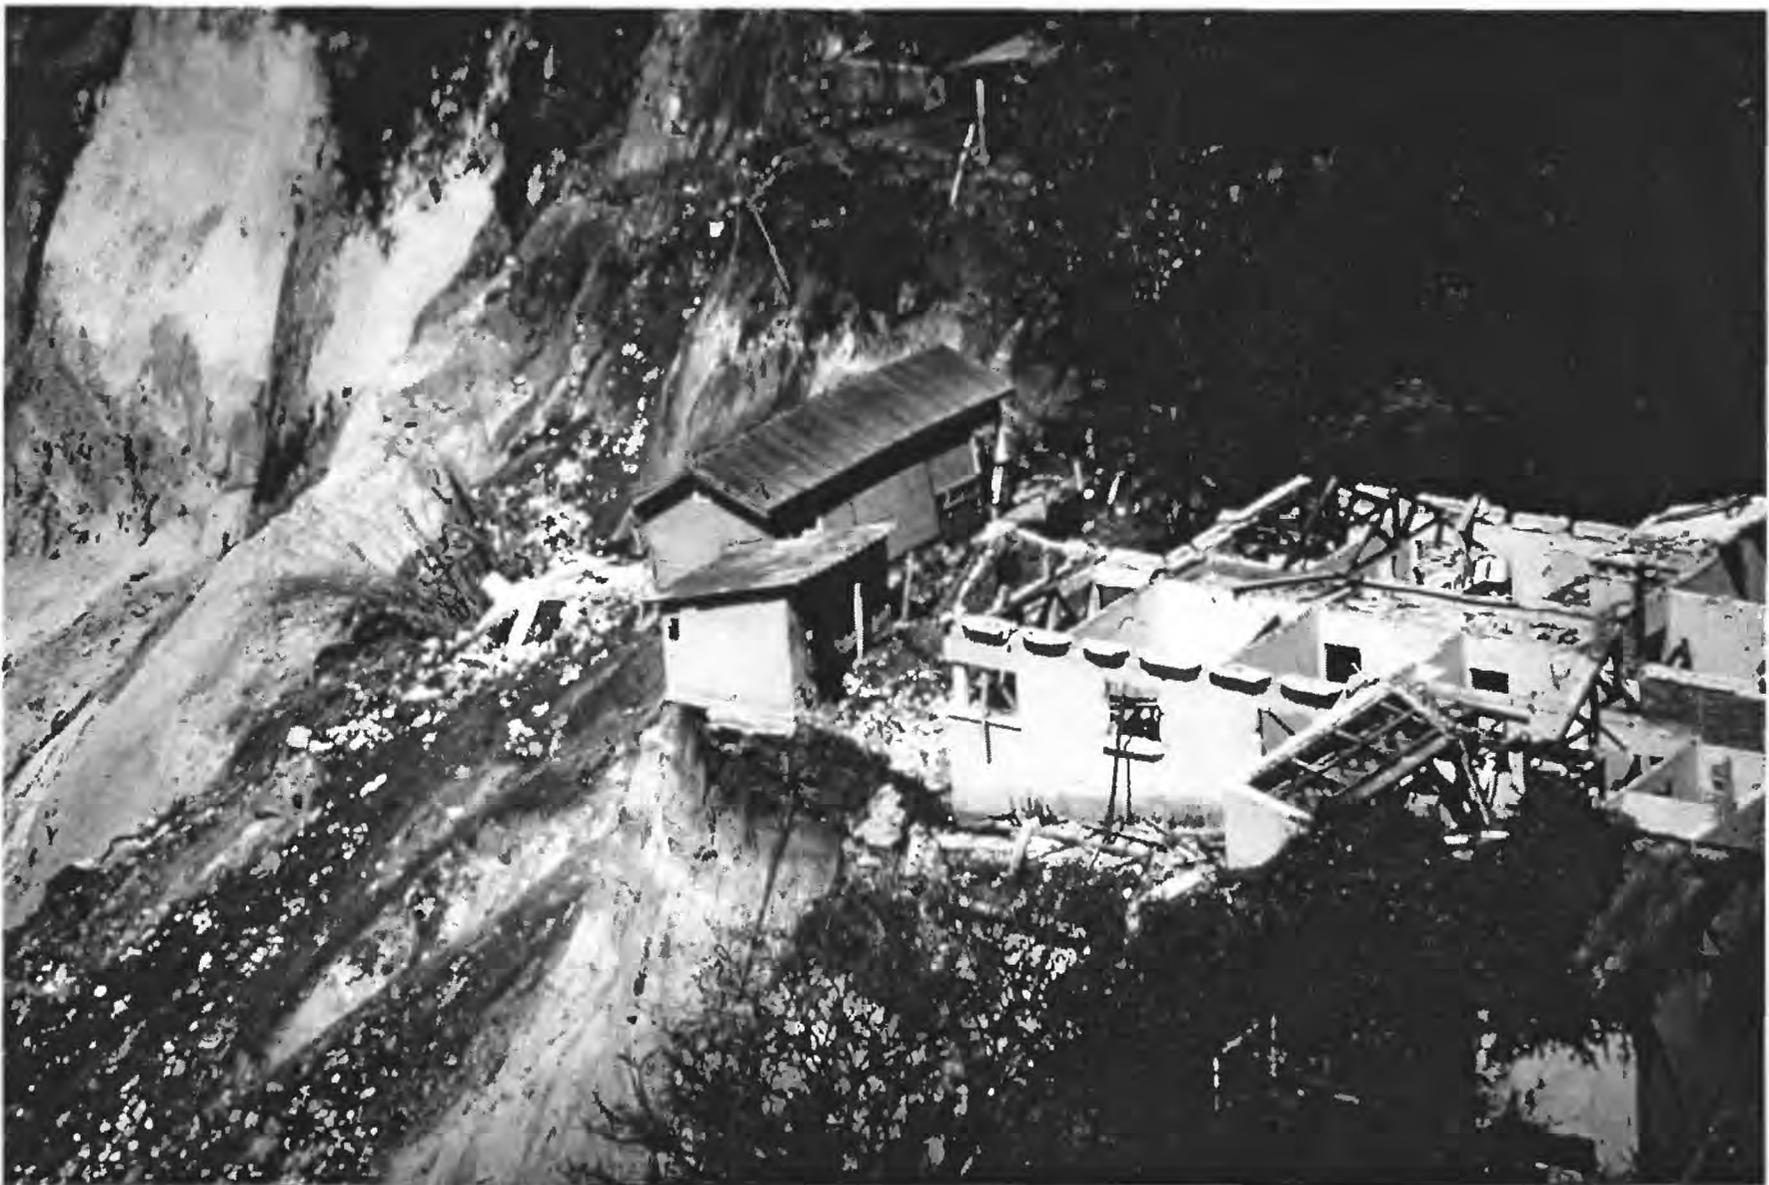
*Figure 7. Damage caused by a landslide triggered by the February 1976 Guatemala earthquake. (Photo by E.L. Harp, U.S. Geological Survey)*

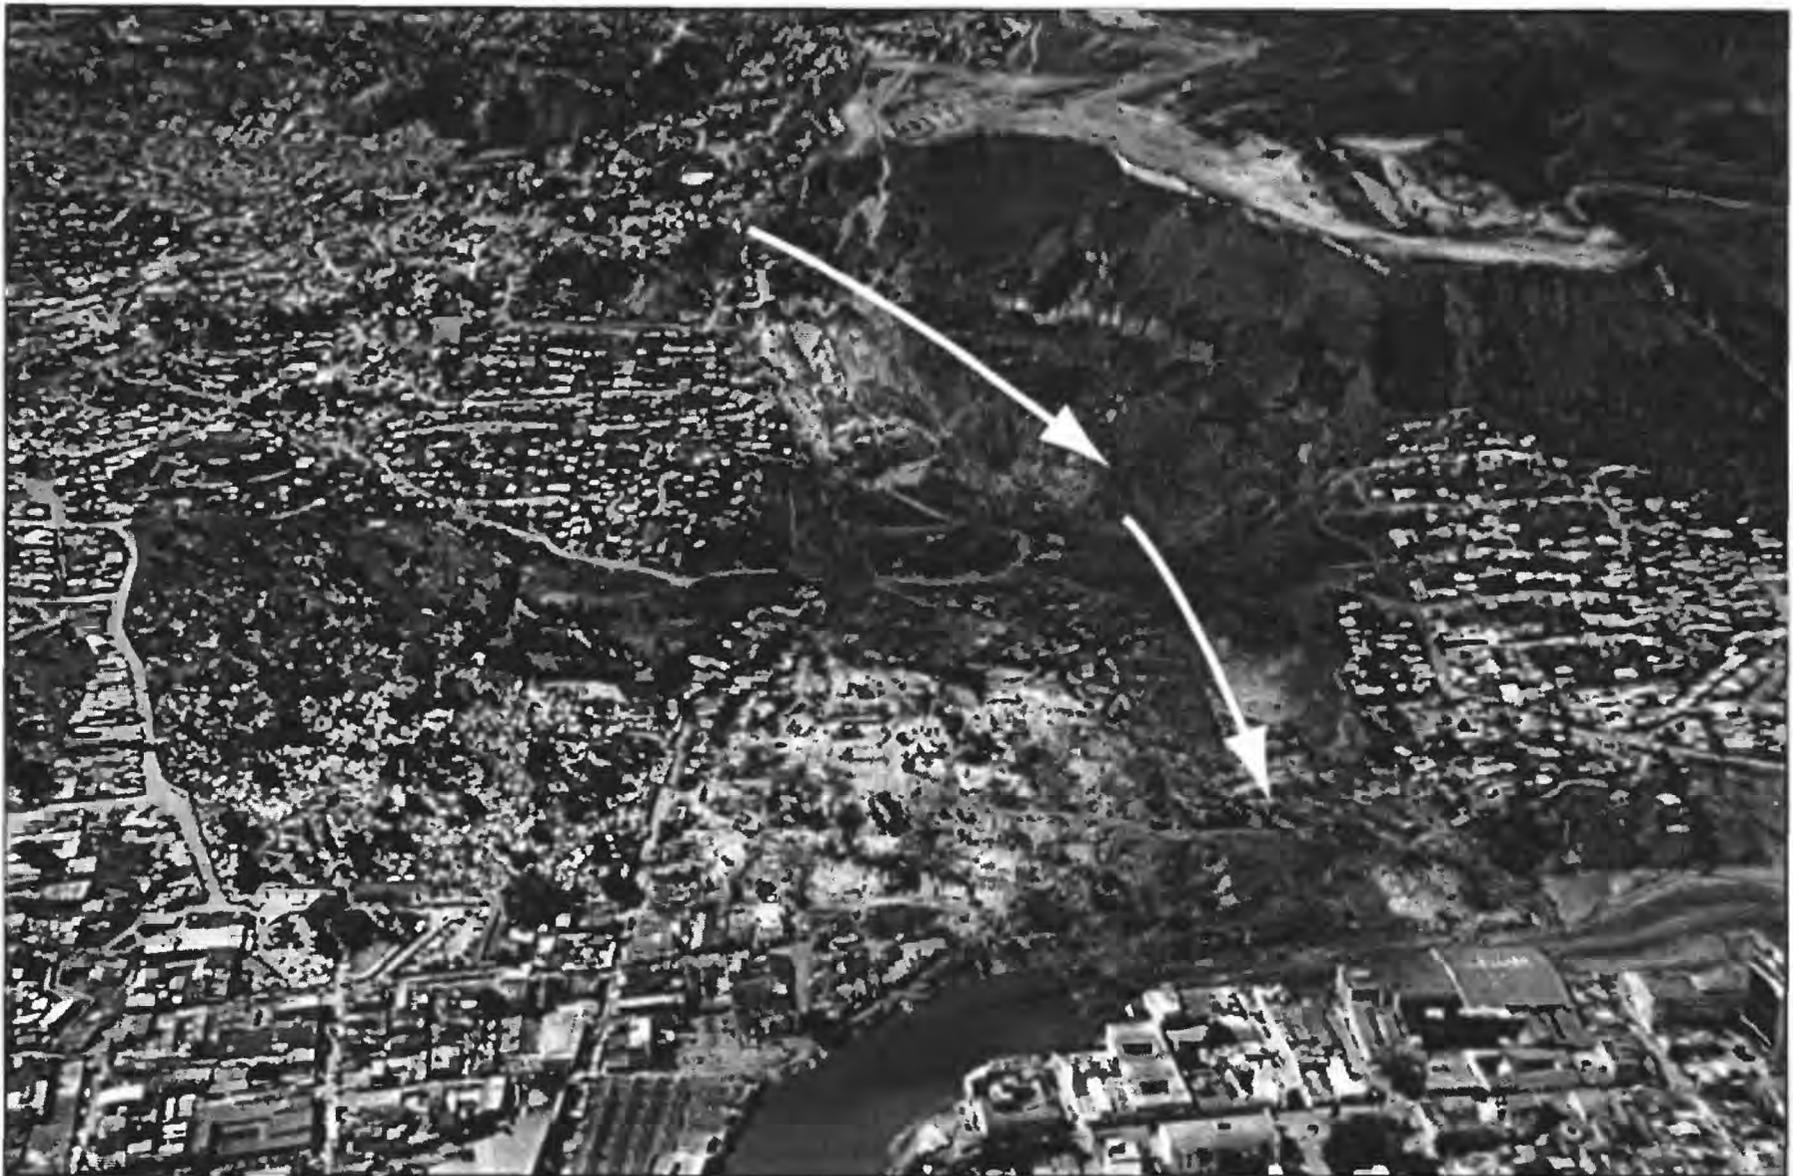
*Figure 8. The El Berrinche landslide, Tegucigalpa, Honduras, which was caused by 1998 Hurricane Mitch. This 6-million-m<sup>3</sup> rotational slump-earth flow destroyed the entirety of the district of Colonia Soto near the center of the city, and temporarily dammed Río Choluteca, creating a lagoon that posed a health problem for the city (Harp, 2001). Arrows show path of landslide debris that dammed the river. (Photo by E.L. Harp, U.S. Geological Survey)*

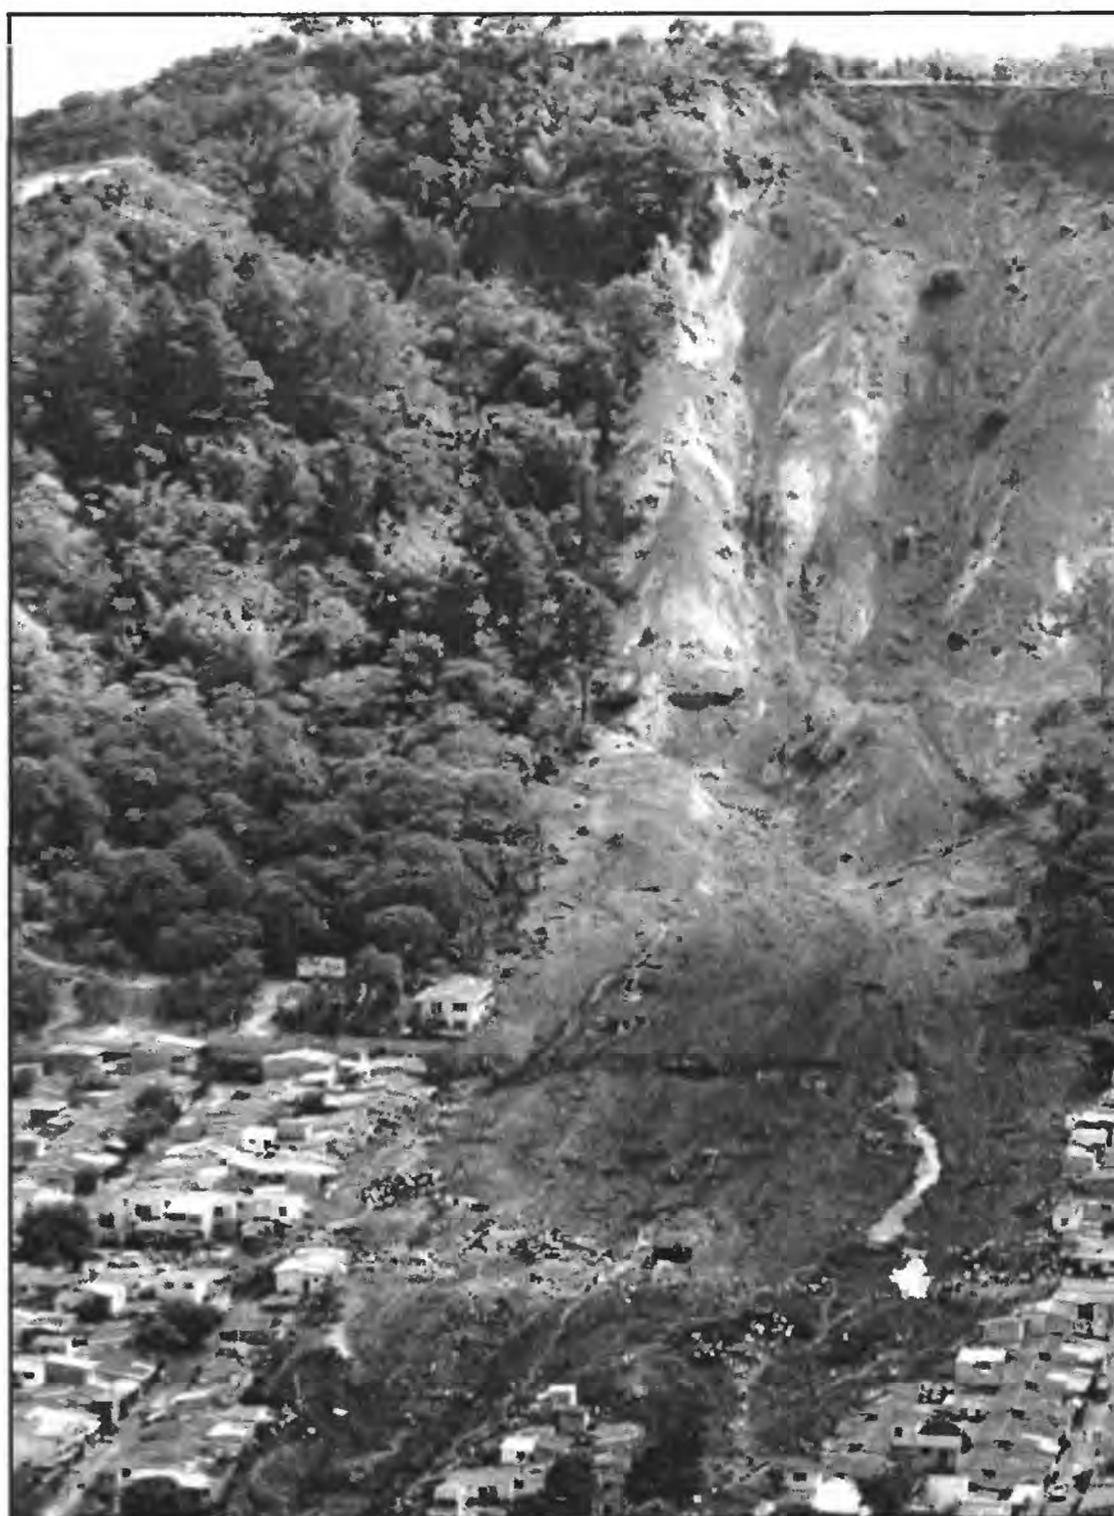
Figure 9. The January 2001 earthquake-induced slide that demolished much of the Las Colinas neighborhood of Santa Tecla, suburb of San Salvador, the capital of El Salvador. (Photo courtesy of AP/Wide World Photos)

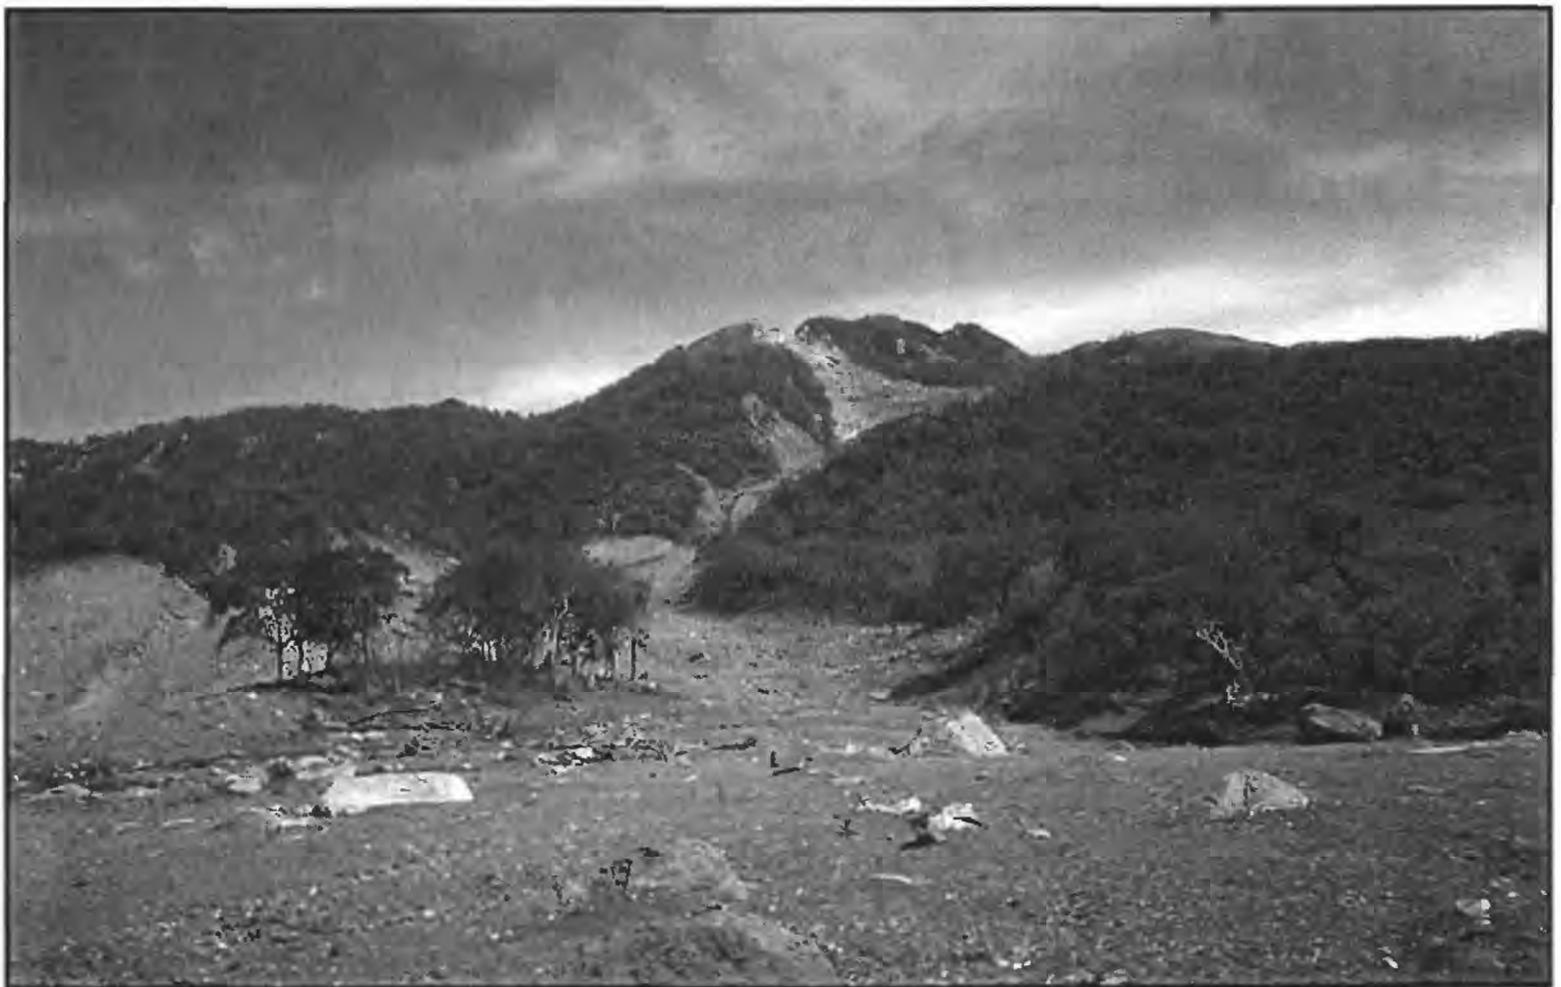
*Figure 11. Landslide on Casita Volcano Nicaragua, which was triggered by 1998 Hurricane Mitch. The landslide began as a small flank collapse of the volcano, but was soon transformed into a large debris flow, which obliterated two towns on the lower slopes of the volcano. (Photo by K.M. Scott, U.S. Geological Survey)*

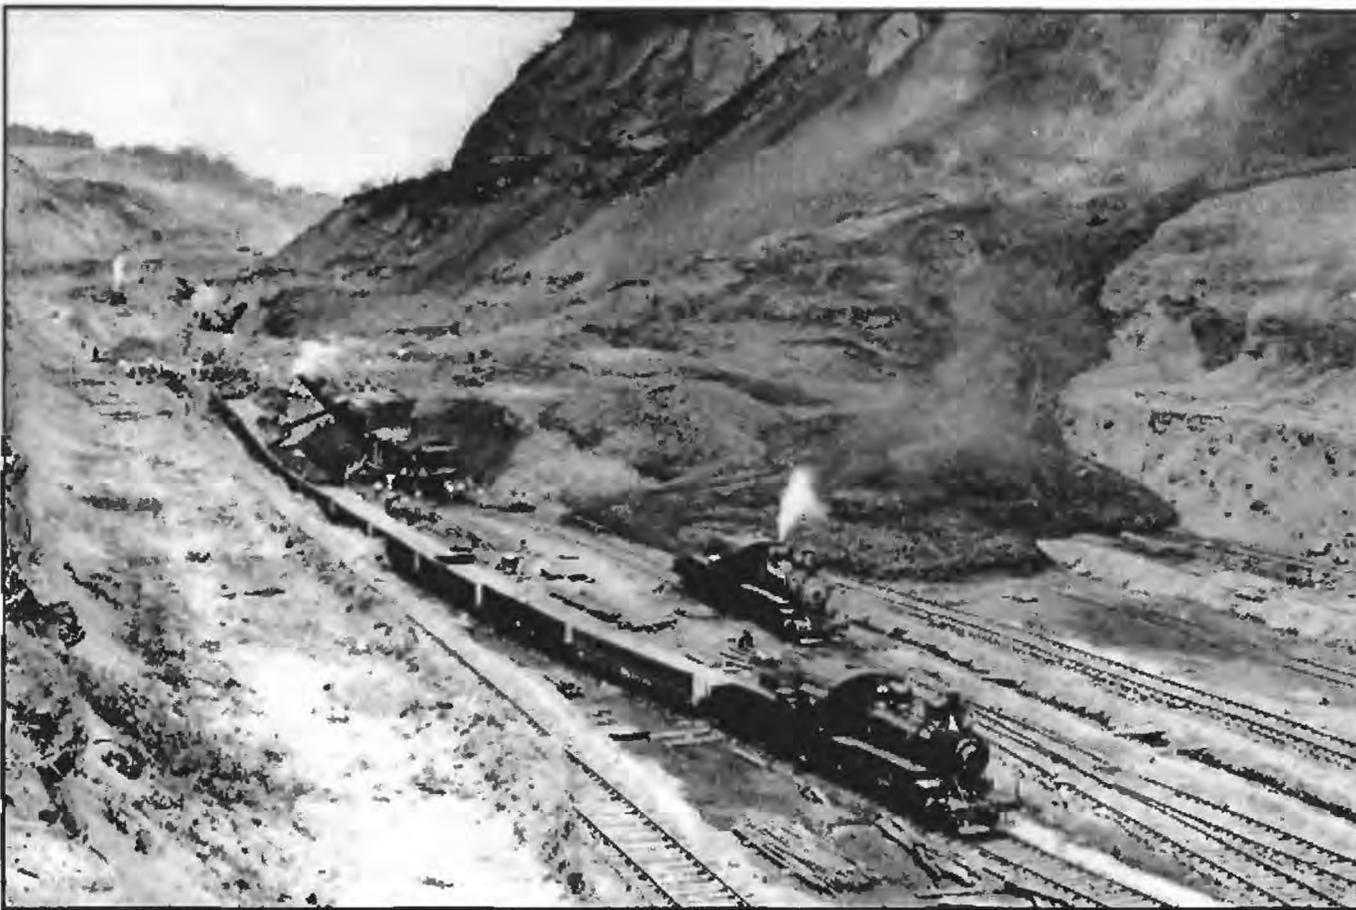
*Figure 12. The 1913 Cucaracha landslide, Gaillard Cut, Panama Canal, which occurred during construction of the canal. Note construction railroad tracks on the bottom of the future canal. Activity of this 2.2-million-m<sup>3</sup> earth slide-earth flow continued during and after filling of the canal (see Fig. 13). (Photo courtesy of the Panama Canal Commission)*

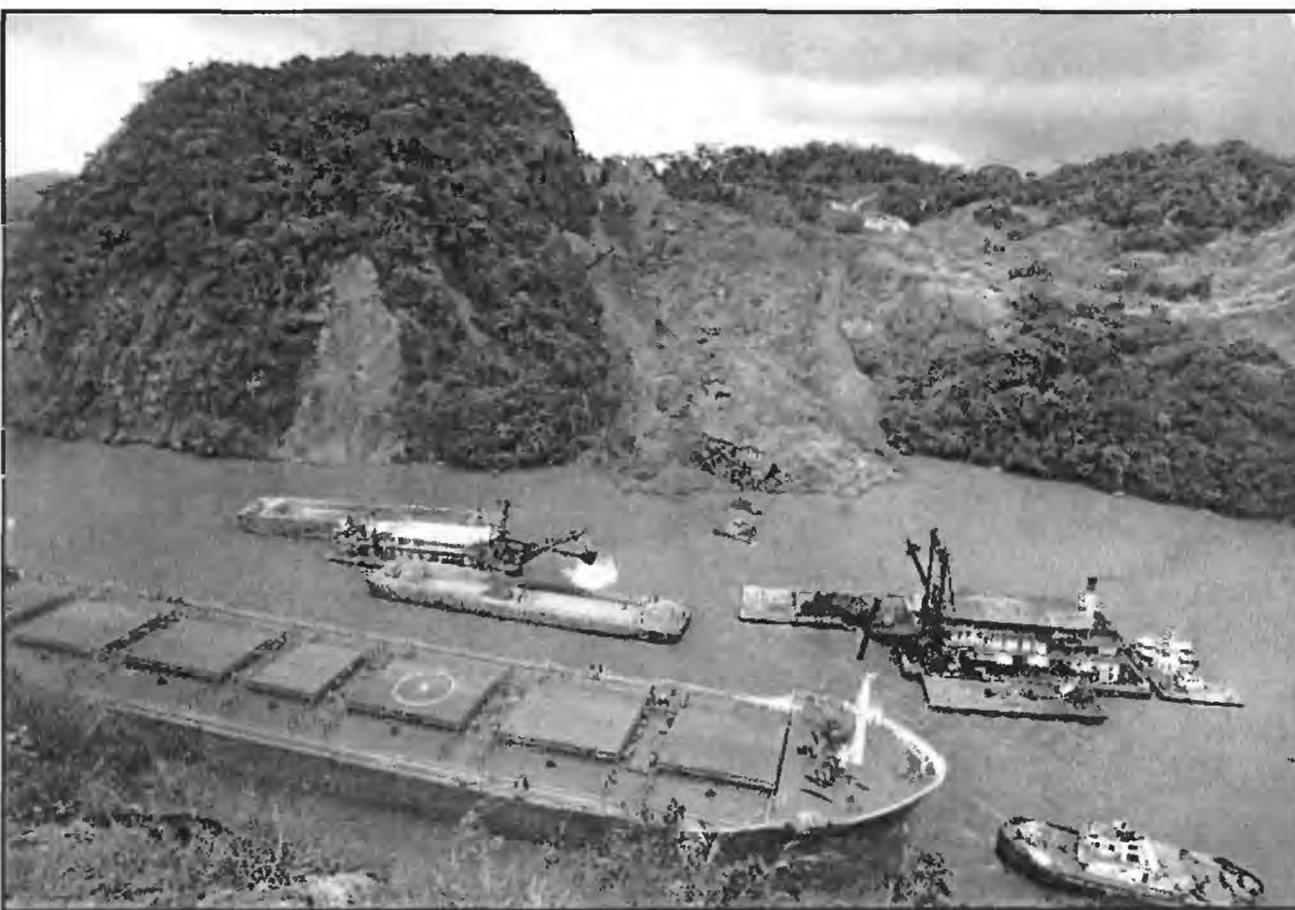
*Figure 13. October 1986 reactivation of the Cucaracha landslide, Gaillard Cut, Panama Canal. The landslide extended nearly across the channel, but much of the toe had been removed by dredges (in the photo) by the time this photo was taken. (Photo courtesy of the Panama Canal Commission)*
