# Socioeconomic and Environmental Impacts of Landslides in the Western Hemisphere

*Robert L. Schuster and Lynn M. Highland*

***Open-File Report 01-276***

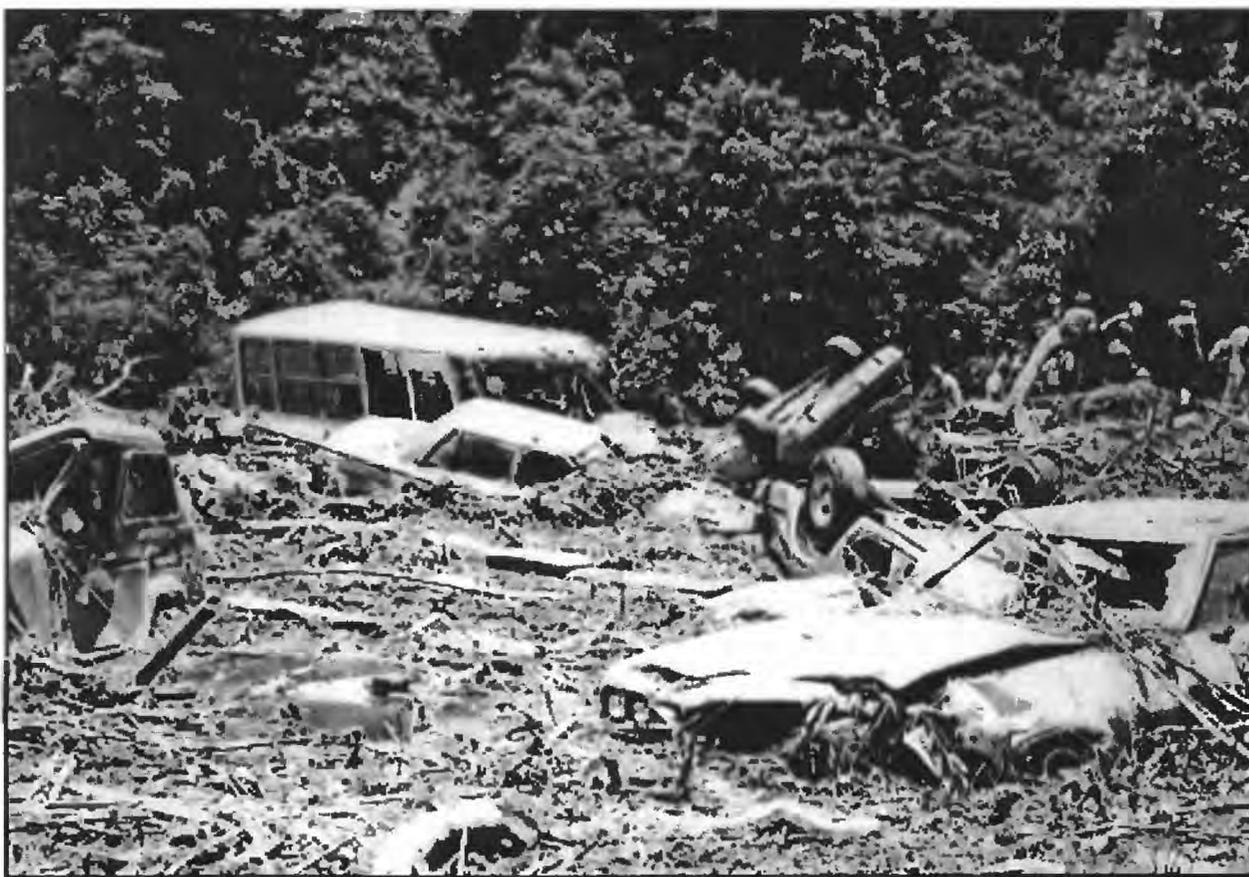
Figure 14. Vehicles destroyed by the September 1987, Río Limón debris flow, Venezuela. (Photo by D.A. Salcedo, Universidad Central de Venezuela)

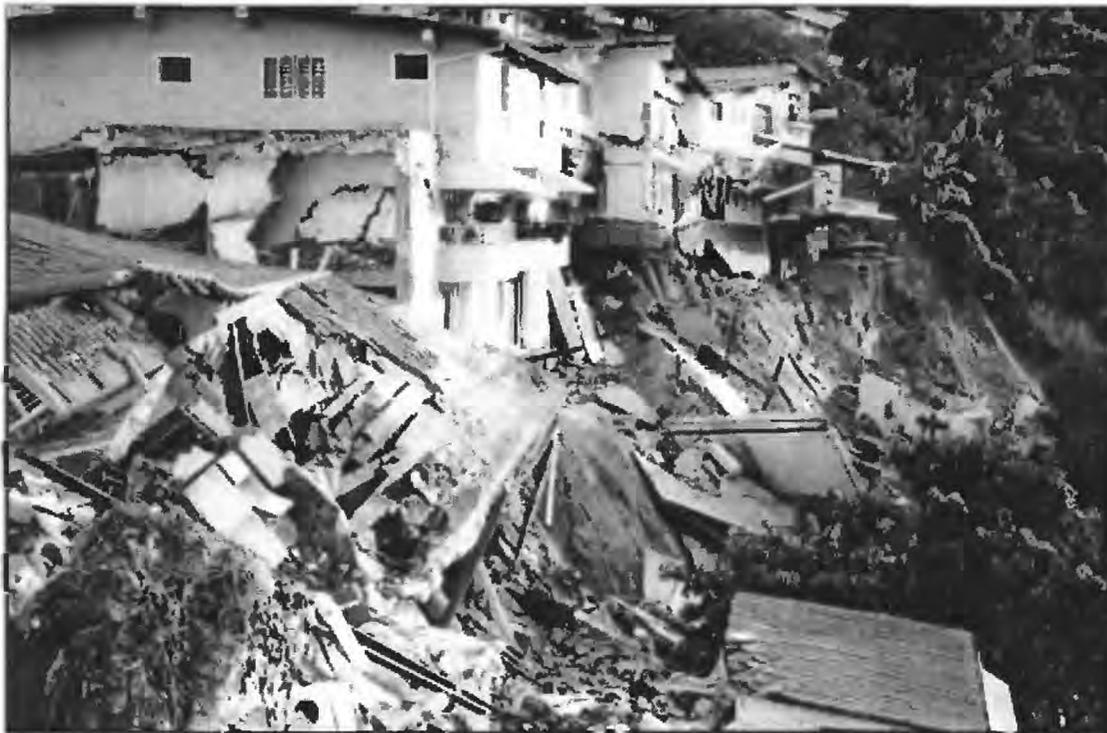
Figure 15. Homes in a high-cost residential neighborhood of Caracas, Venezuela, that were destroyed in September 1993 by a rainfall-triggered landslide. (Photo by D.A. Salcedo, Universidad Central de Venezuela)

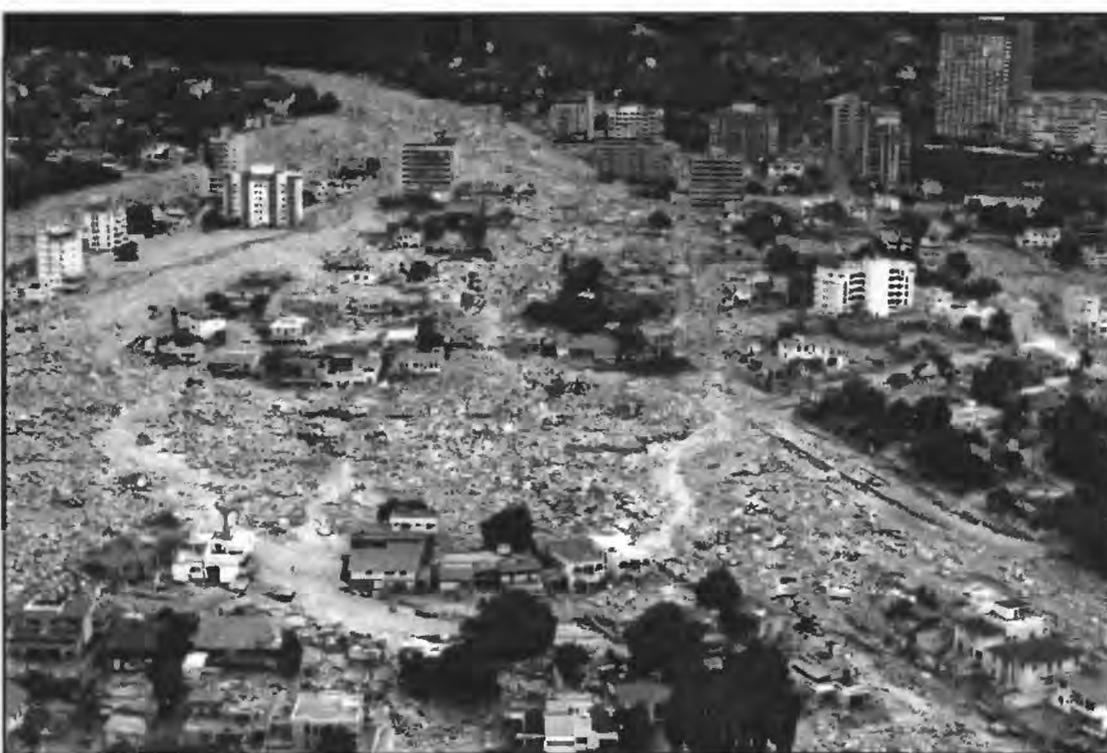
Figure 16. December 1999 debris-flow damage to the city of Caraballeda, north coast of Venezuela. (Photo by L.M. Smith, Waterways Experiment Station, U.S. Army Corps of Engineers)

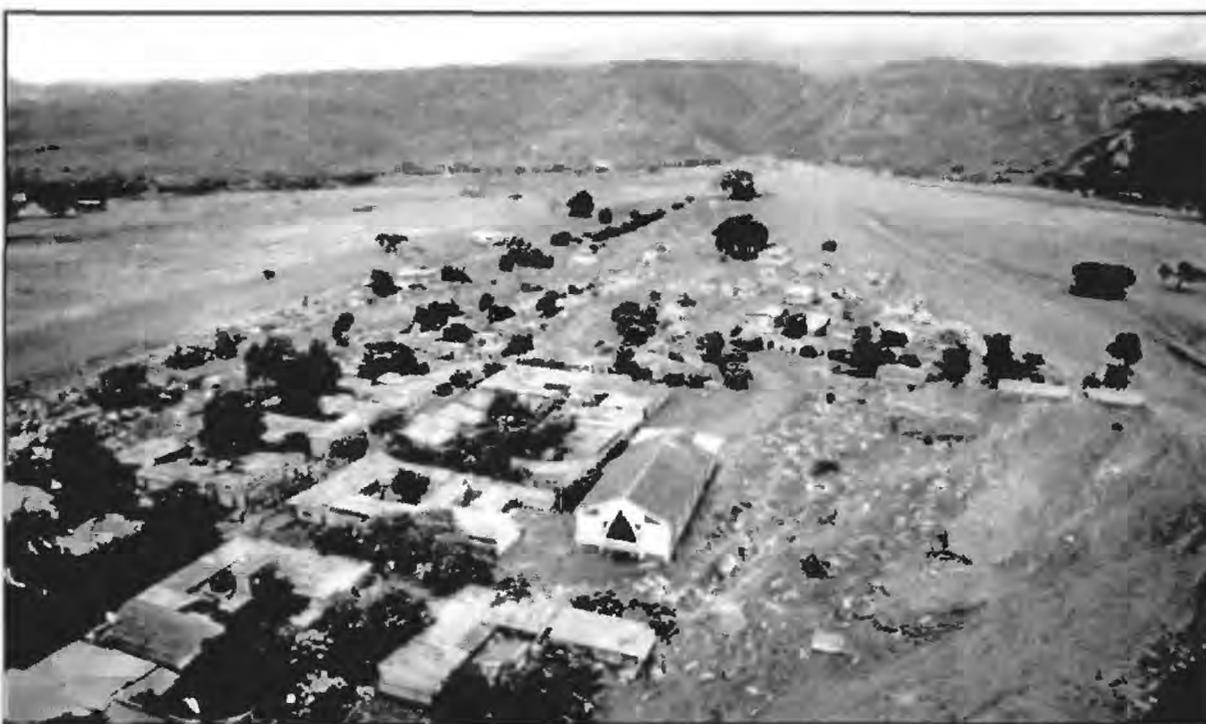
*Figure 17. Remains of the city of Armero, Colombia, following the 1985 eruption of Nevado del Ruiz, which triggered debris/mud flows (lahars) that overwhelmed the city of 29,000. (Photo by Steve Raymer, courtesy National Geographic magazine)*

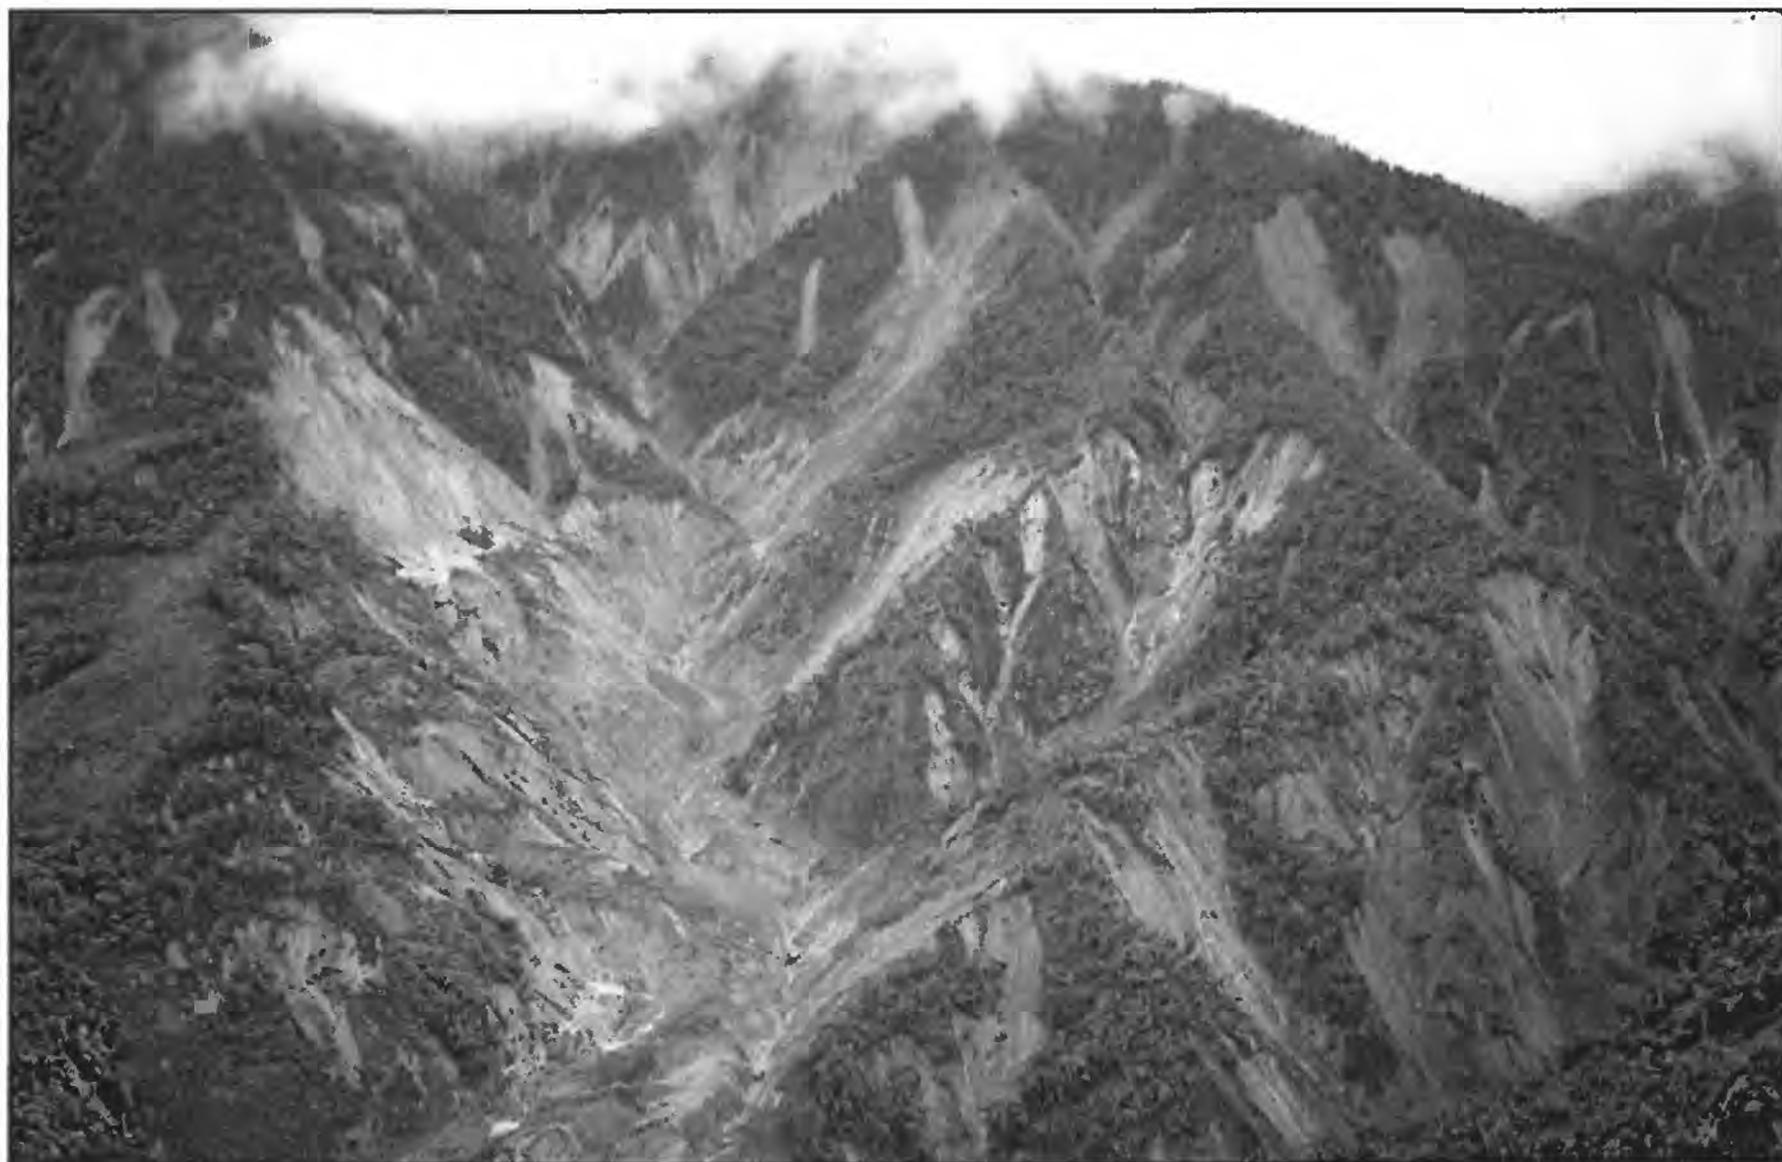
*Figure 18. Destruction of vegetative cover on valley walls of the upper Río San Vicente, a tributary of the Río Paez, southwestern Colombia, by thin slides, debris avalanches, and debris flows triggered by the June 1994 Paez earthquake. (July 1994 photo)*

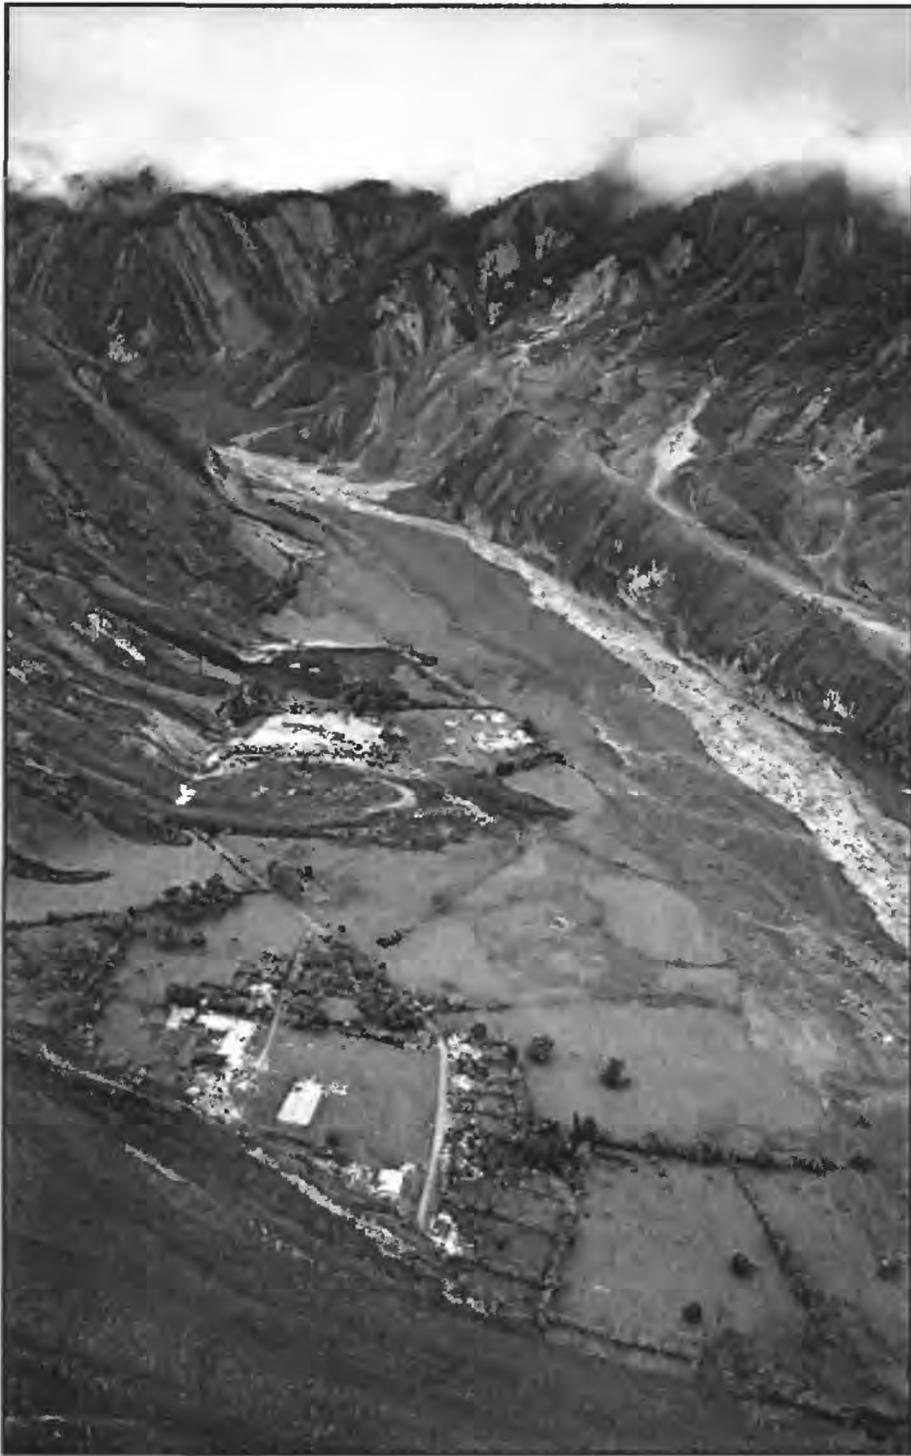
Figure 19. Debris flows at the village of Irlanda, southwestern Colombia. The main flow followed the Río Paez (right-side of photo); smaller flows entered from valley wall at the left. Homes, a school, and other buildings were destroyed in Irlanda (center and foreground). (U.S. Geological Survey photo, July 1994)

The largest flows followed the valleys of the Río Paez and its tributaries for a maximum distance of 120 km from the source area (Martinez et al., 1999). In the upper 35 km, debris/mud flows destroyed farms and villages located near the rivers (Fig. 19). In the downstream 85 km, mud flows in the Río

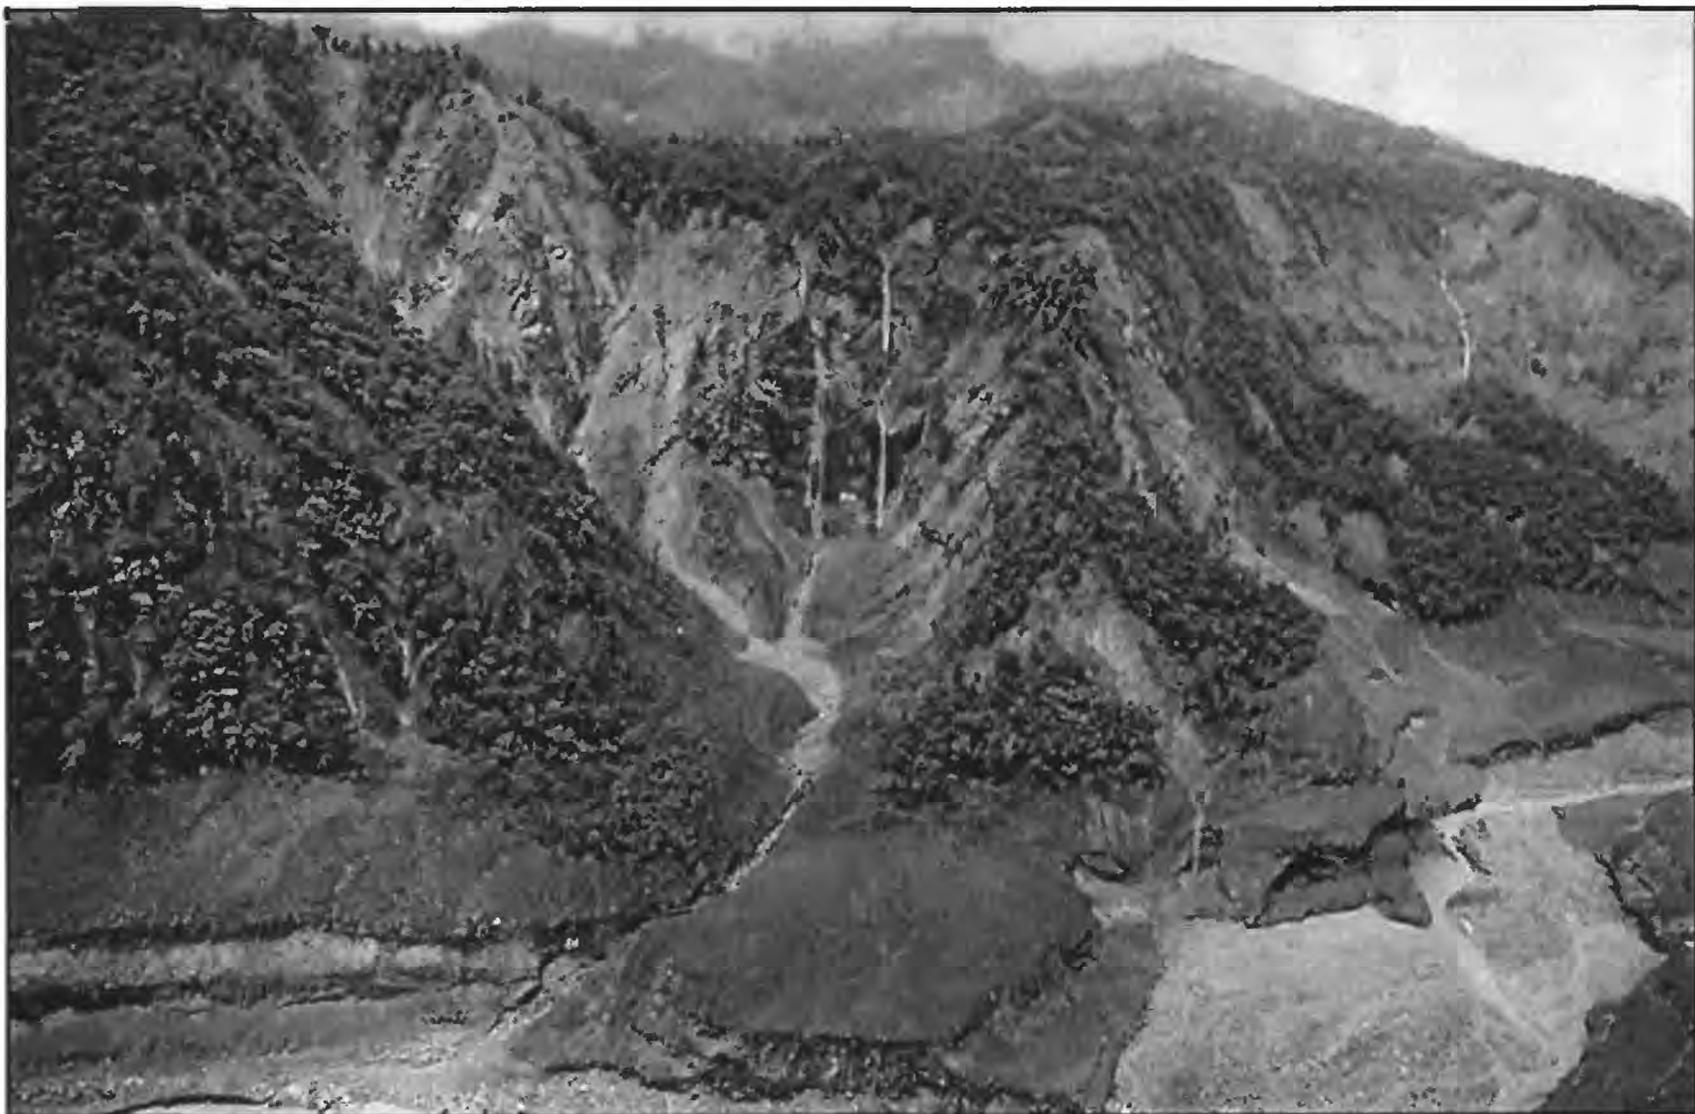
*Figure 20. View of valley wall of the Río Malo, a tributary of the Río Coca, northeastern Ecuador, after the 1987 Reventador earthquakes. Note the severe denudation of slopes due to thin slips/avalanches/flows and of the valley bottom due to debris flows and flooding.*

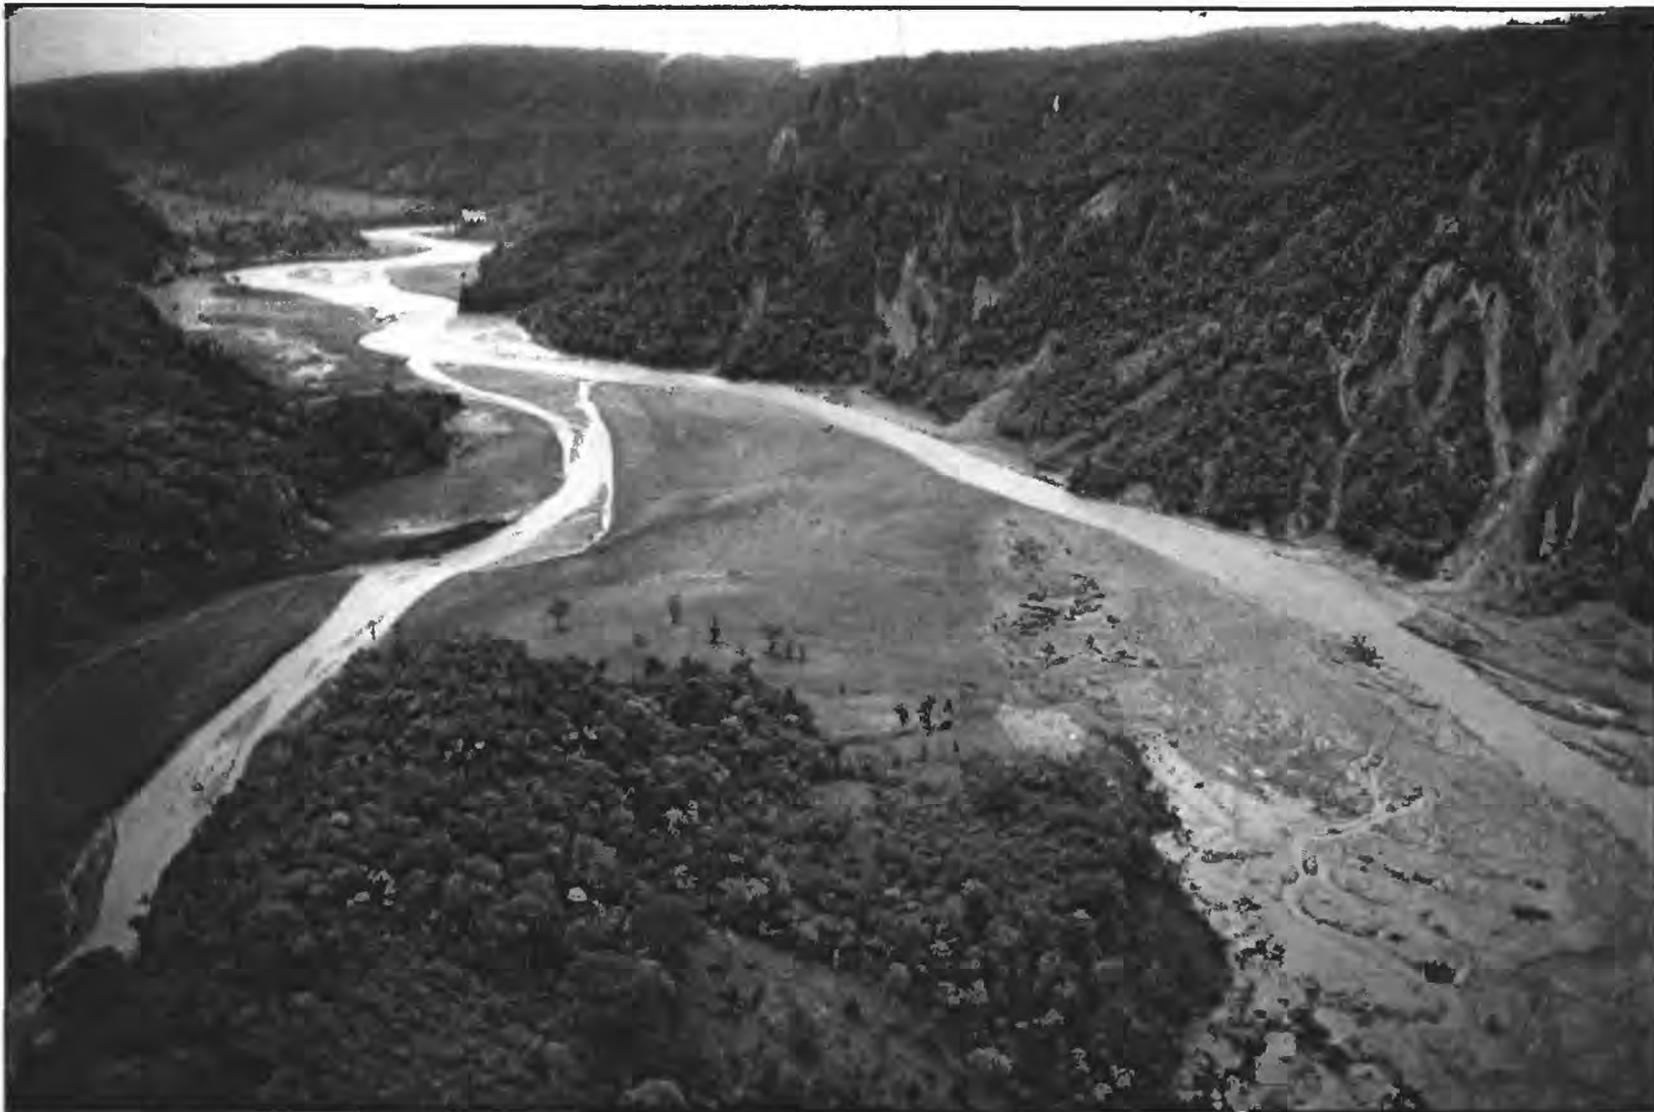
*Figure 21. Looking downstream at the confluence of the Río Malo (flowing from lower left) and the Río Coca, north-eastern Ecuador. Both river channels have been choked by sediment left behind by debris flows triggered by the 1987 Reventador earthquakes.*

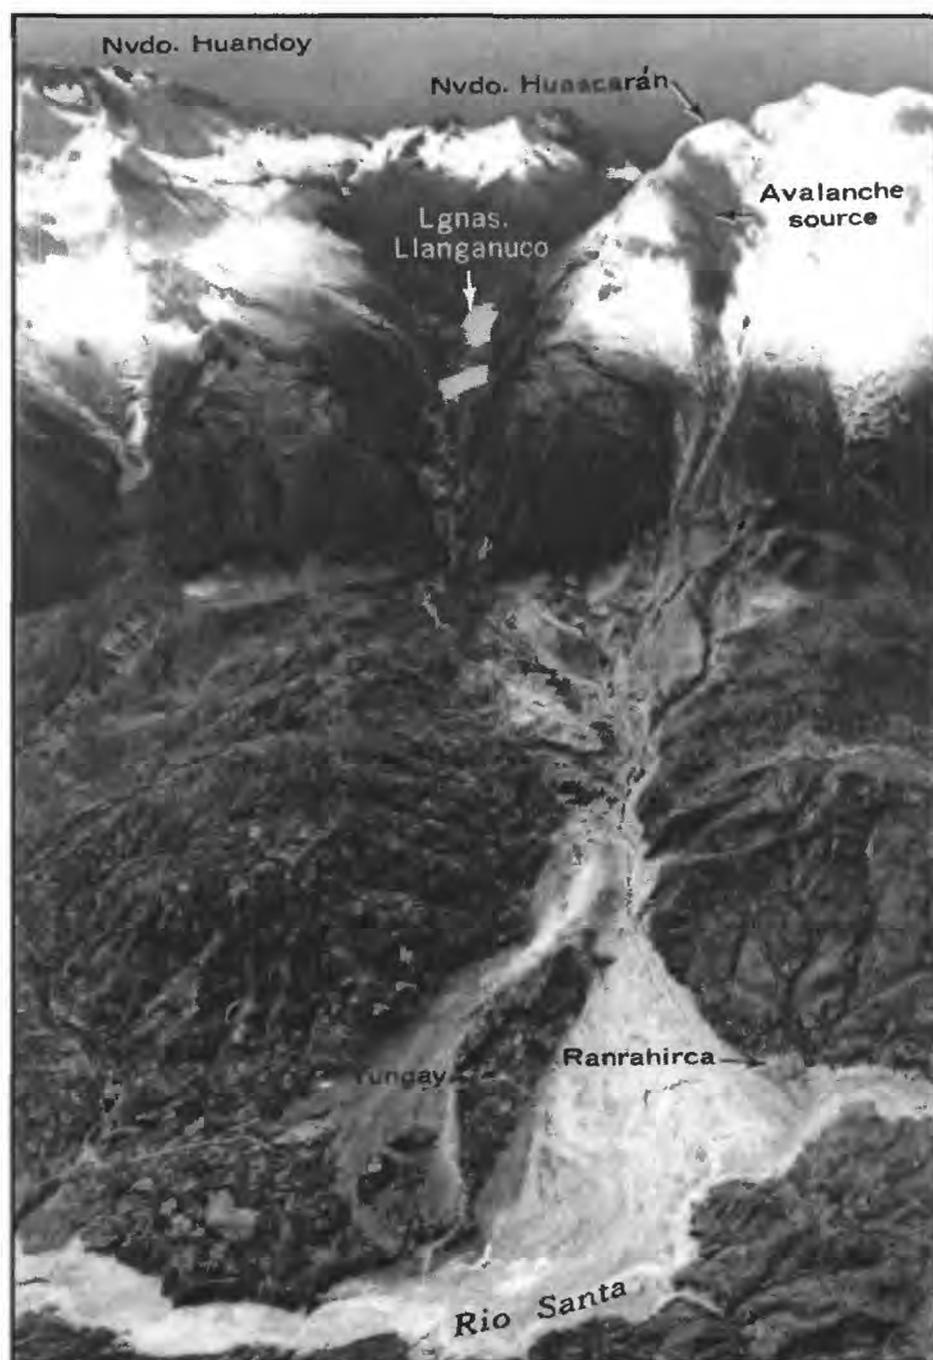
Figure 22. The 1970 debris avalanche on Nevado Huascaran, Peru, which destroyed the town of Yungay and much of the town of Ranrahirca (lower foreground), killing about 18,000 people. (Photo courtesy of Servicio Aerofotografico Nacional de Peru, June 13, 1970)

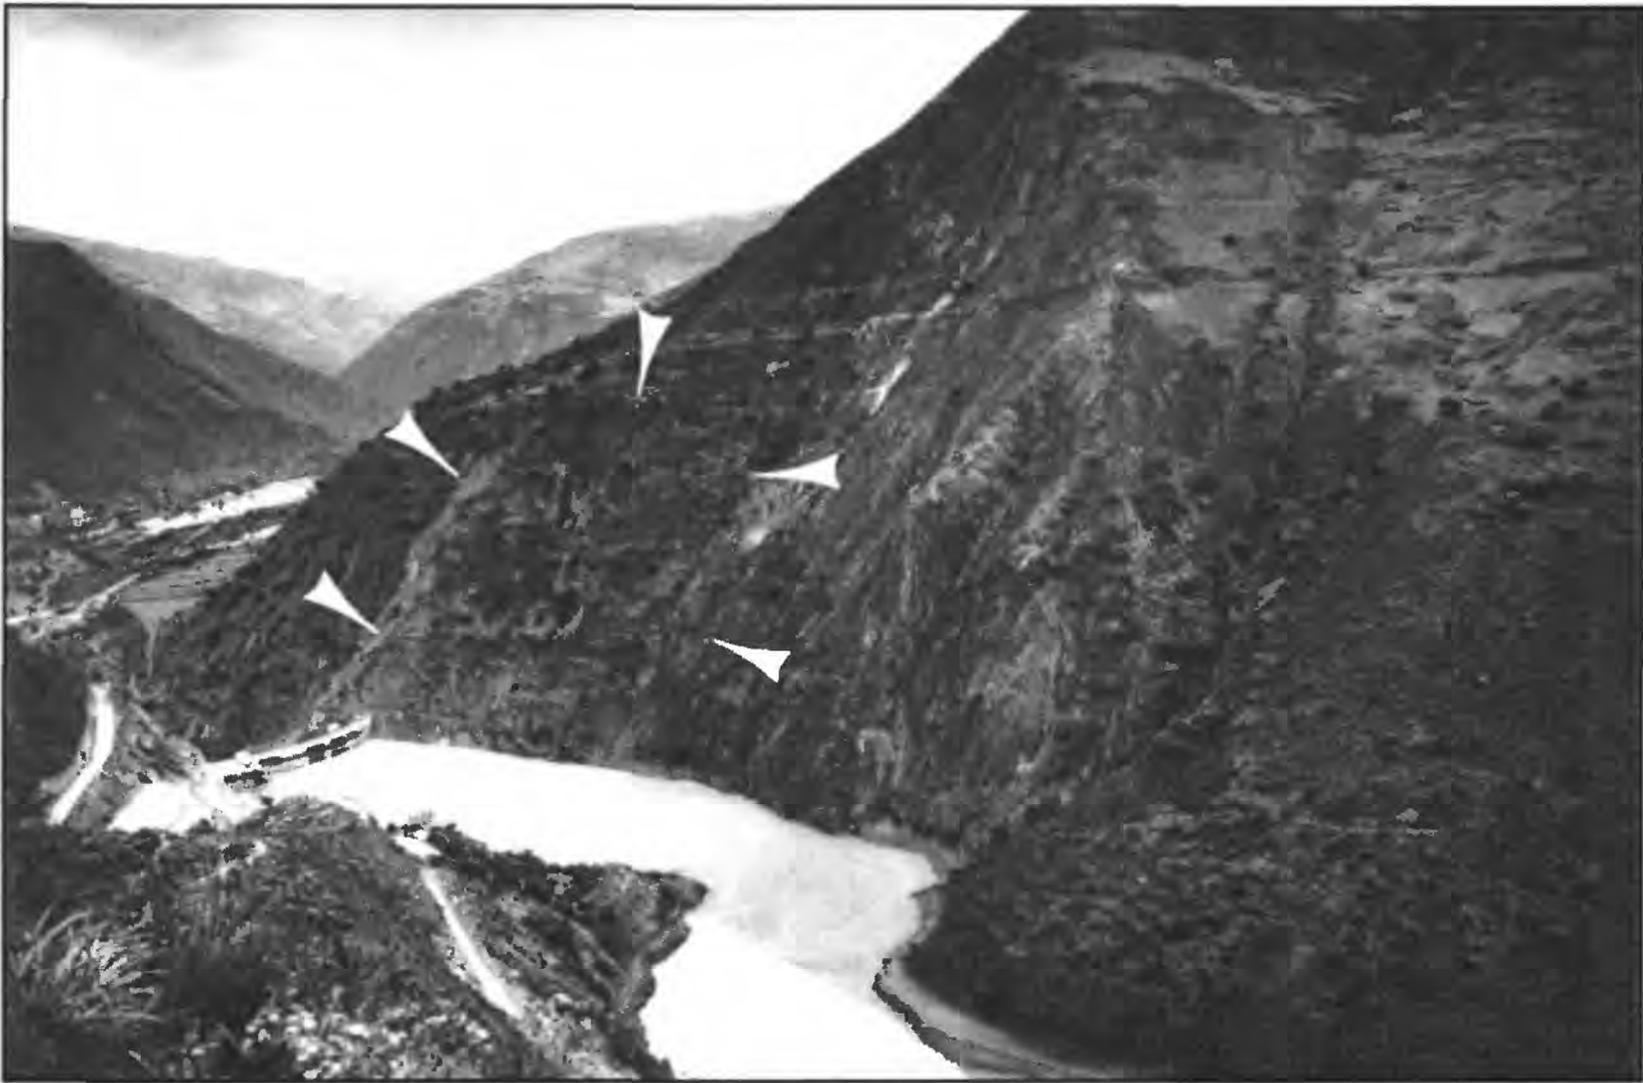
Figure 23. Creeping rock slide (arrows) endangering Tablachaca Dam, Río Mantaro, Peru, before costly control measures, consisting mainly of a reservoir-level earth buttress, surface and subsurface drainage, and rock anchors, were used to reduce the threat of slope failure to Peru's largest hydropower dam. (Photo, February 1982)

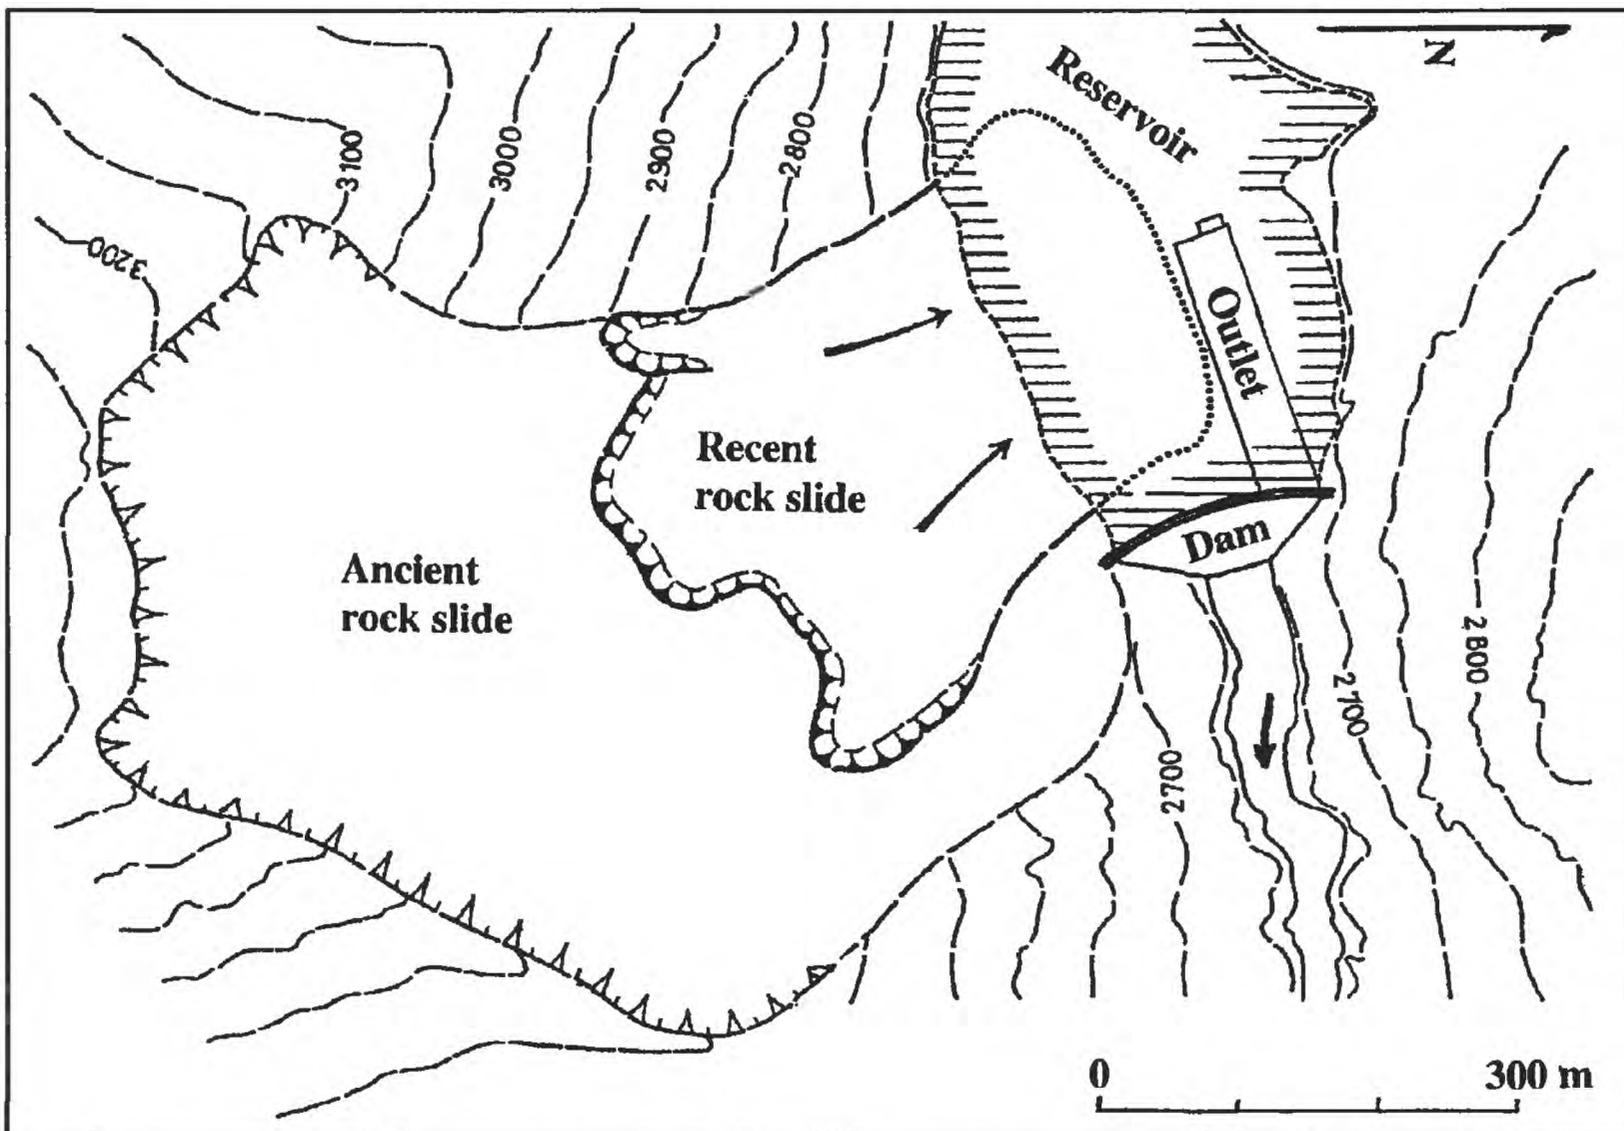
Figure 24. Map of right-abutment landslide, Tablachaca Dam, Peru (Novosad, 1979).

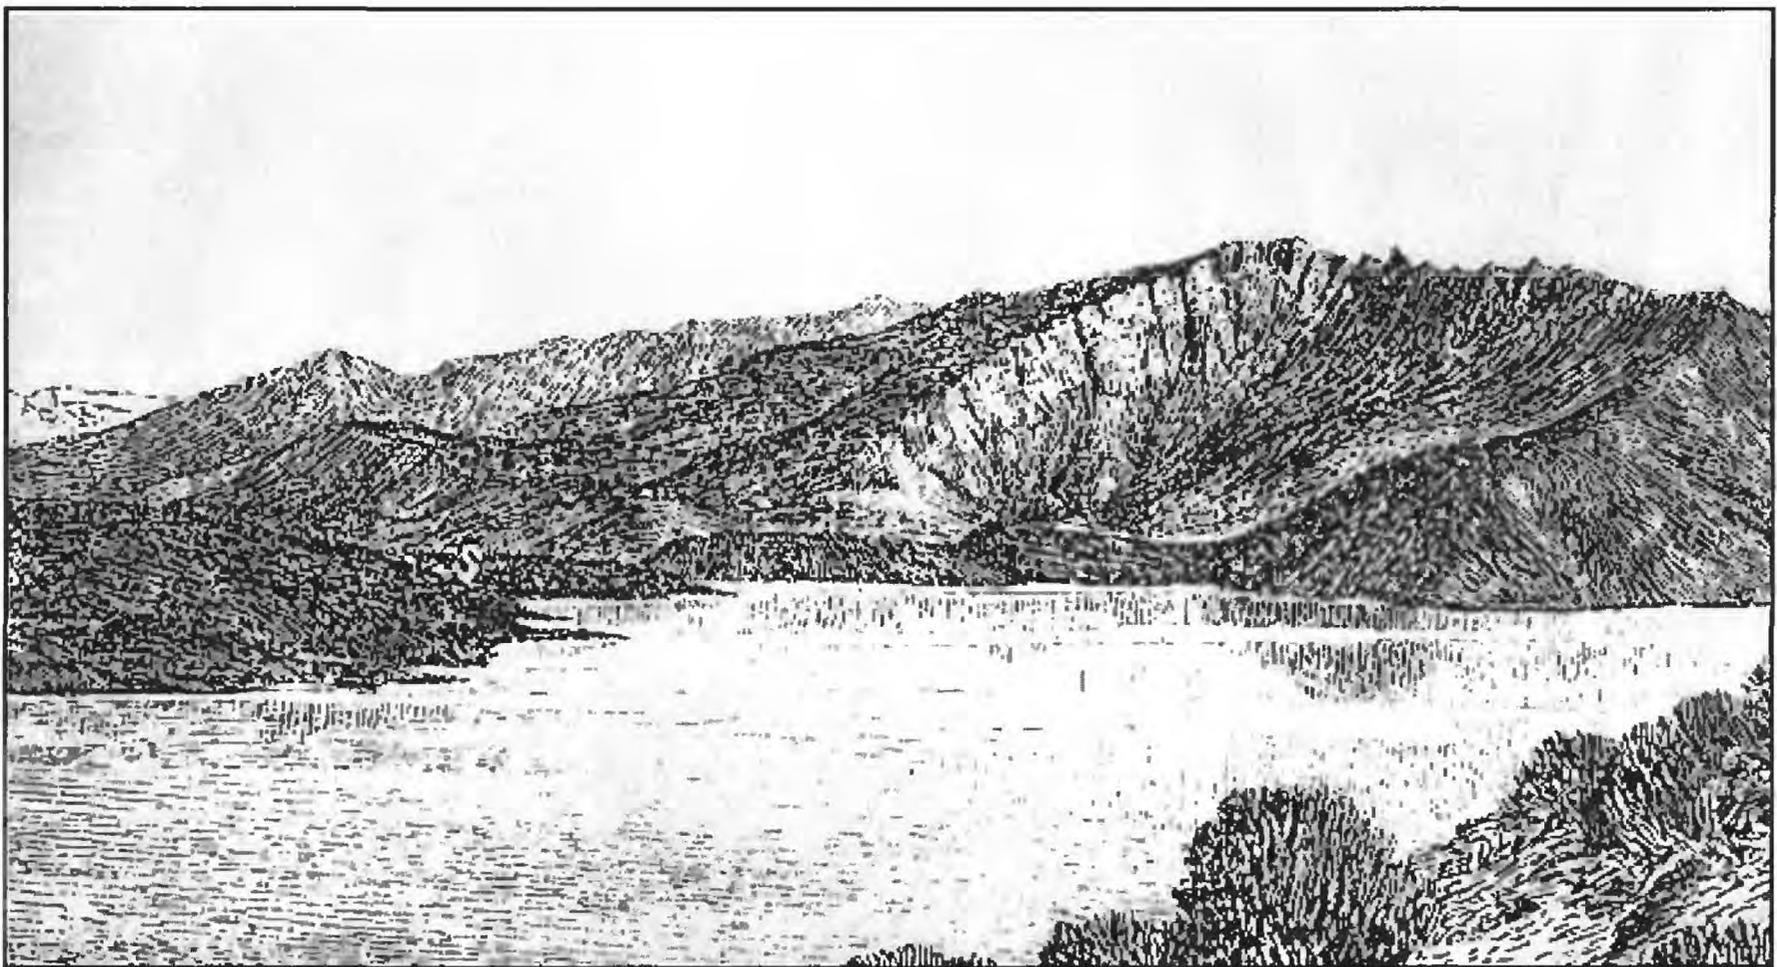
*Figure 25. Sketch of Lake Cari Lauquen on the Río Barrancas, Argentina, and of source of prehistoric landslide that dammed the river. Sketch shows status of the lake after partial failure of the natural dam in 1914. Location of outlet of the lake is indicated by the “S” near left edge of sketch. (Sketch by P. Groeber; Groeber, 1916)*

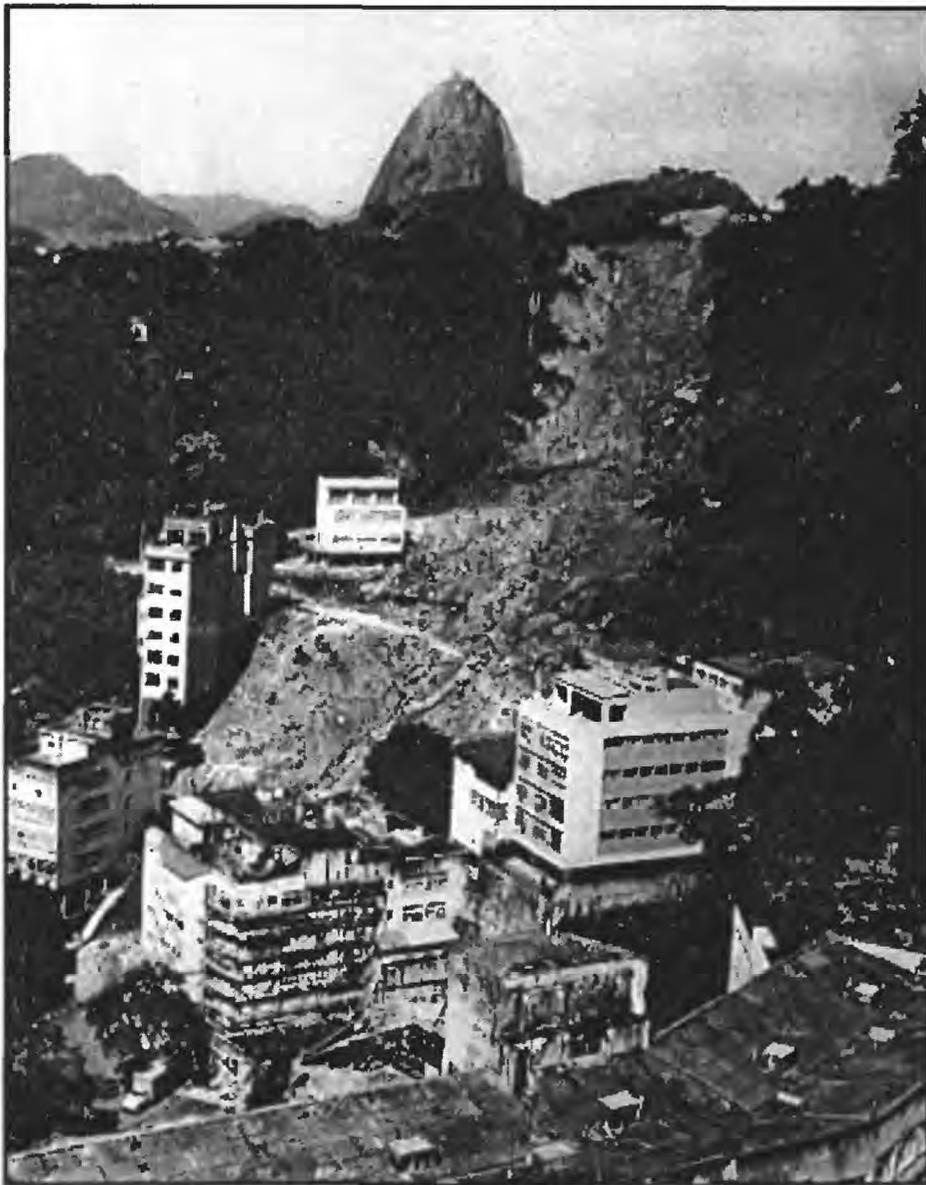
Figure 26. February 1967 Bairro Jardim-Laranjeiras landslide, Rio de Janeiro, which destroyed two apartment buildings and killed 110 people (Da Costa Nunes et al, 1979). (March 20, 1967 photo by Ruy Macial, Geo-Rio, Rio de Janeiro)

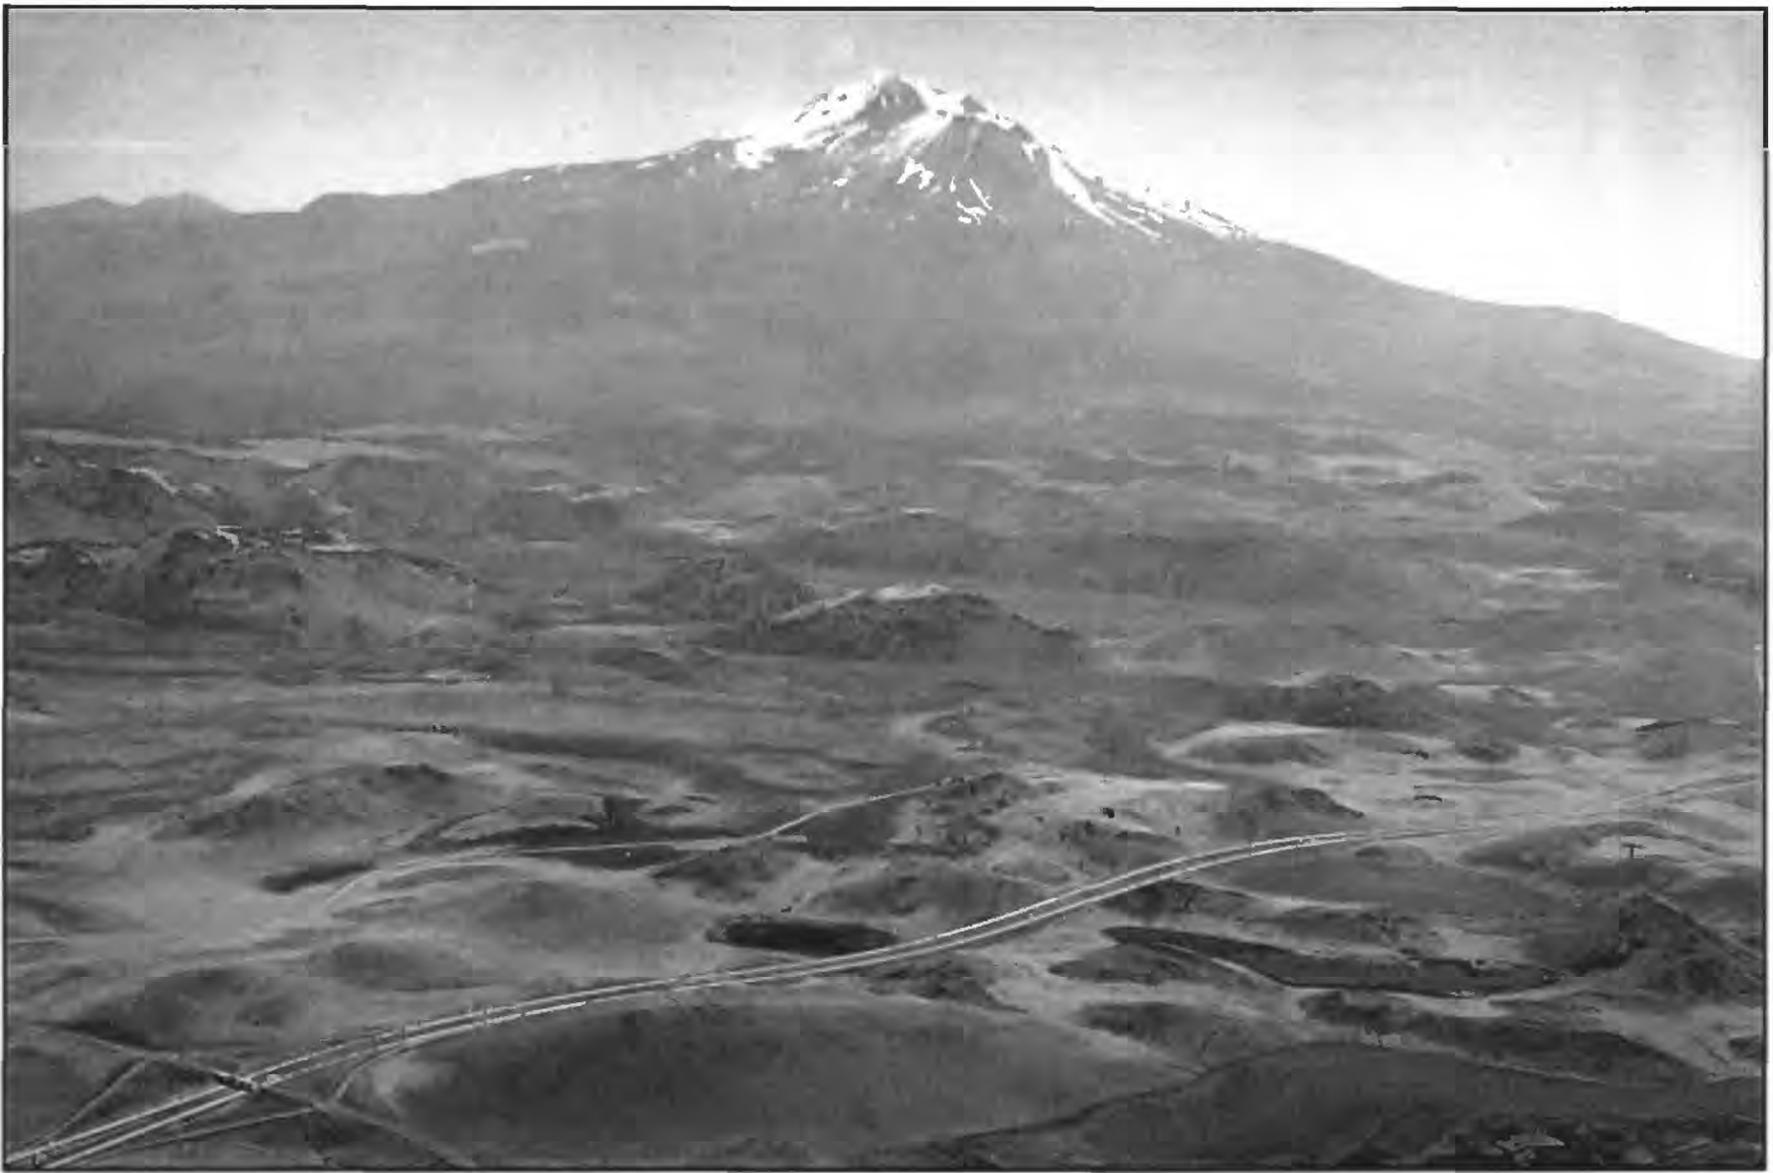
Figure 27. Mount Shasta, California, and the ancestral debris avalanche (foreground) triggered by an eruption some 300,000 yrs B.P.

*Prehistoric Mount Shasta Debris Avalanche, California, U.S.A.* – About 300,000-360,000 yr B.P., a major eruption of Mount Shasta volcano in the Cascade Range of northern California resulted in a huge debris avalanche (estimated volume: 26 km<sup>3</sup>) that extended 43 km northwestward from the base of the volcano (Crandell et al., 1984) (Figs. 27 and 28). This huge landslide deposit and its moon-like surface were not recognized as such until after the 1980 eruption of Mount St. Helens (described below), which resulted in a similar, but smaller, disruption of the Earth's surface.

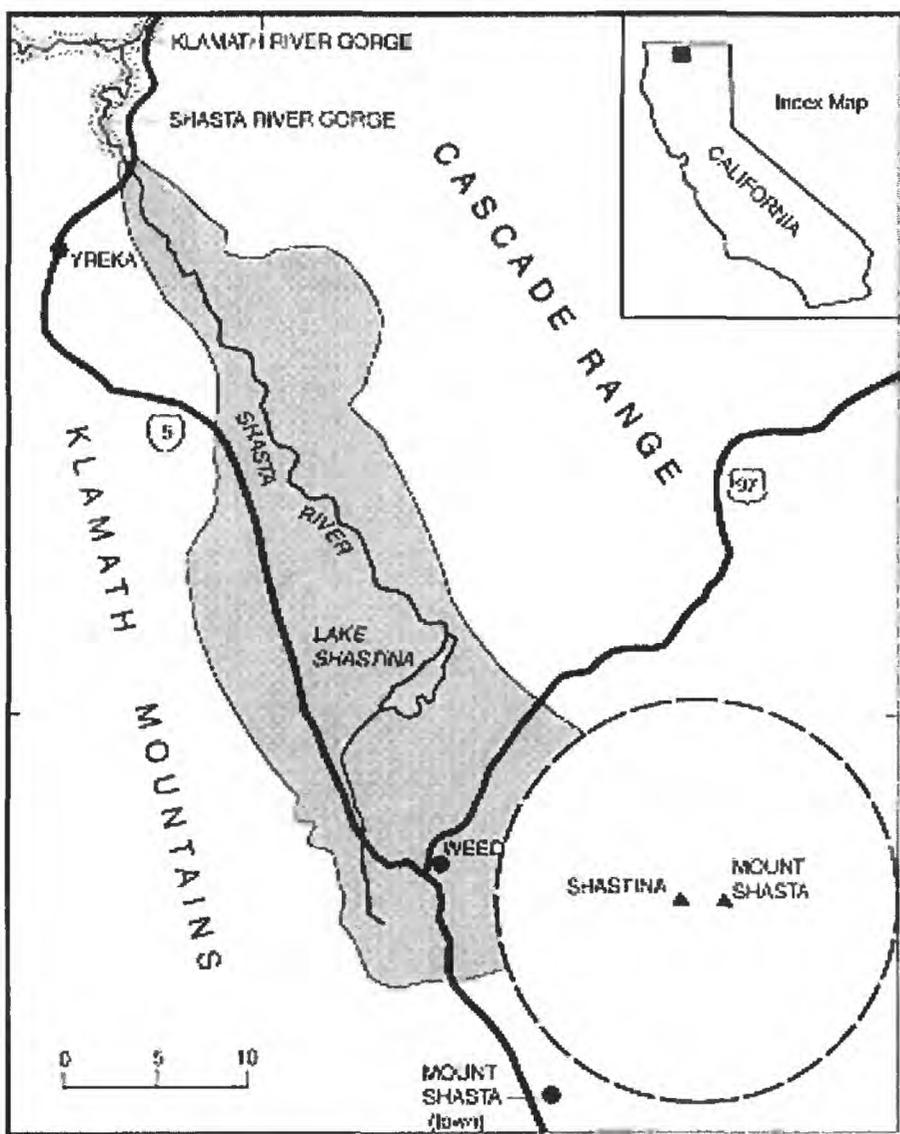
Figure 28. Sketch map of ancestral Mount Shasta debris avalanche. Dashed circle shows approximate outline of base of Mount Shasta (after Crandell et al., 1984).
