# Socioeconomic and Environmental Impacts of Landslides in the Western Hemisphere

*Robert L. Schuster and Lynn M. Highland*

***Open-File Report 01-276***

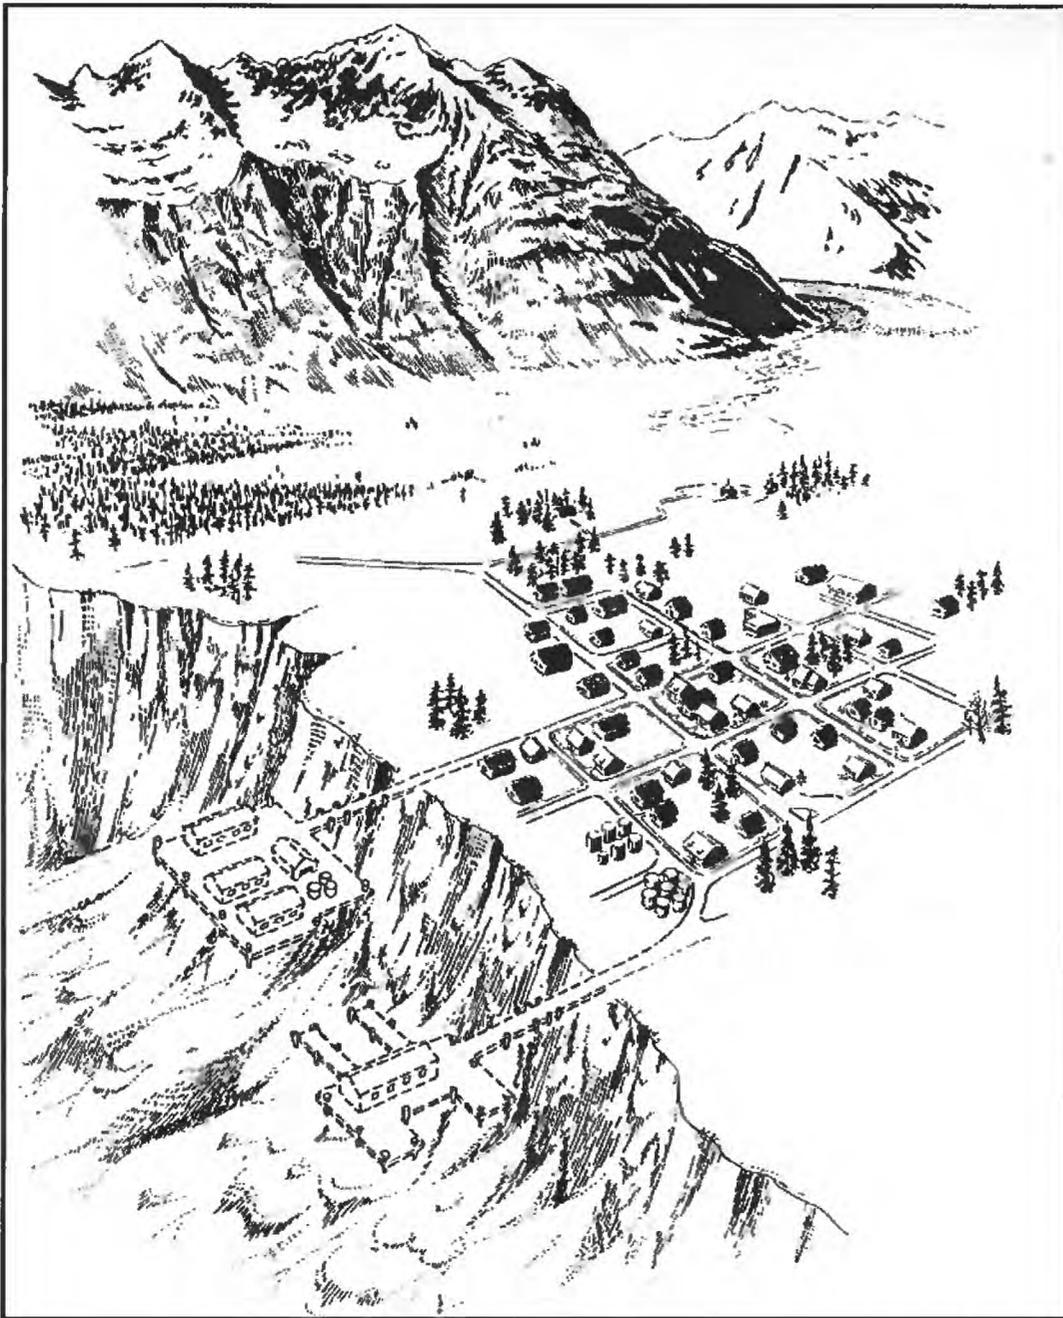
Figure 29. Destruction of port facilities at Valdez, Alaska, U.S.A., by a submarine landslide triggered by the March 1964 Alaska earthquake (Coulter and Migliaccio, 1966). (Sketch by David Laneville, U.S. Geological Survey)

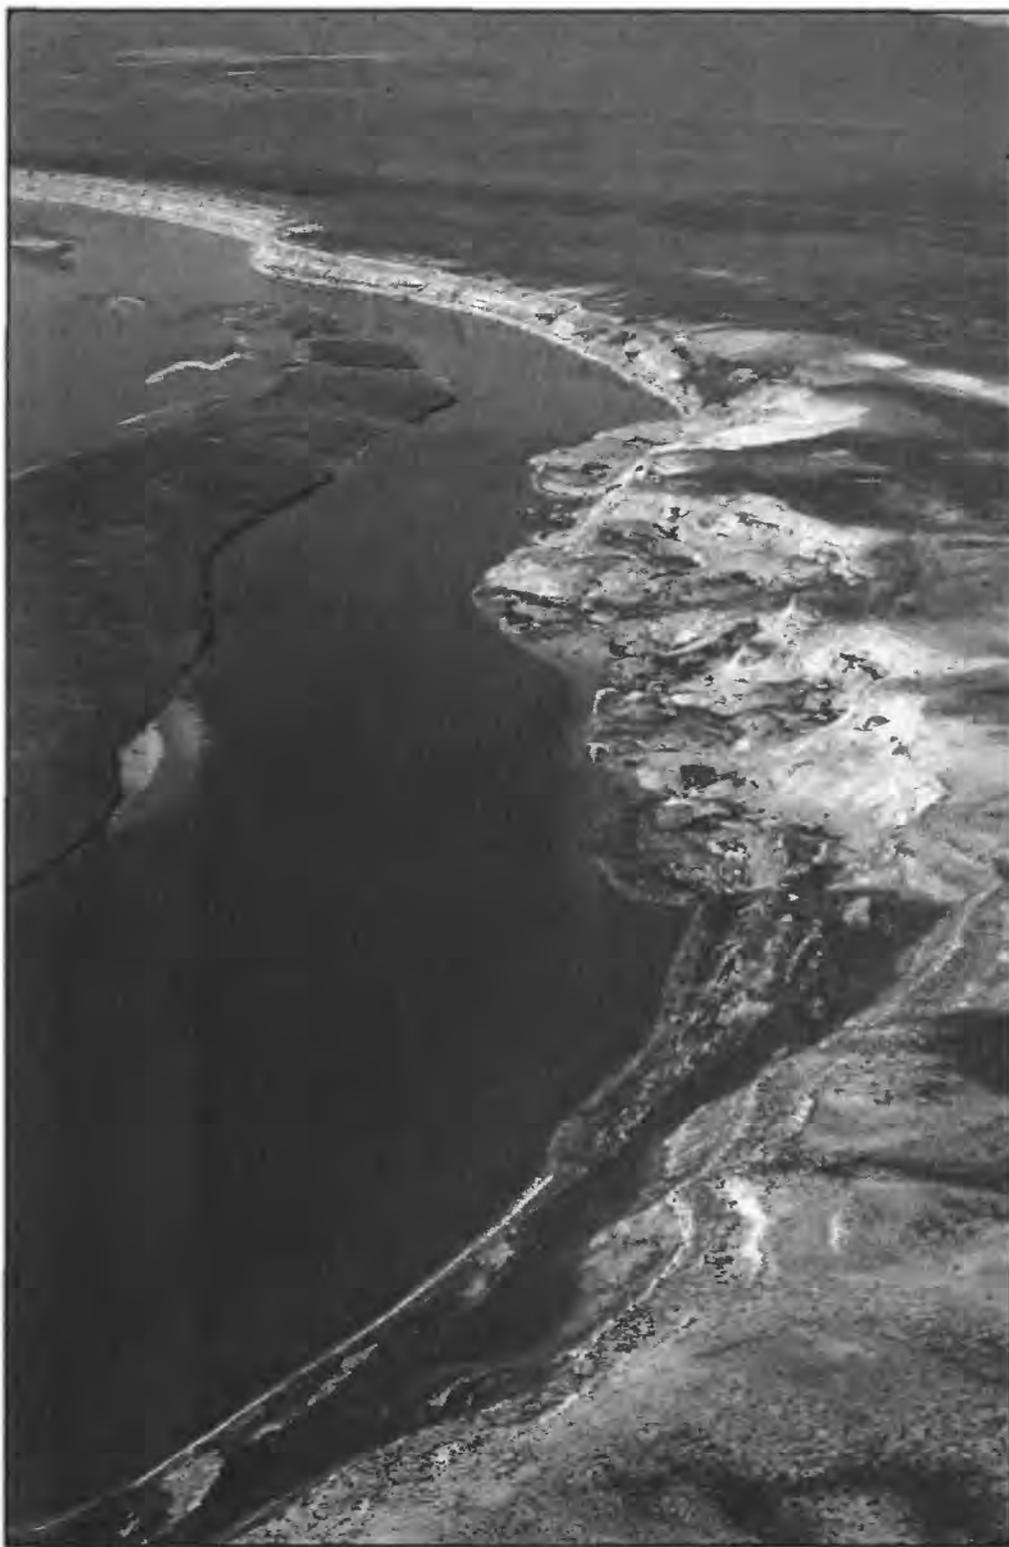
*Figure 30. Irrigation-caused landslides have badly damaged salmonid spawning grounds in the last free-flowing stretch of the Columbia River, Washington State, U.S.A.*
